INFRASTRUCTURE COMMISSION

Infrastructure Commission : May 14, 2026 at 6:00 PM
Village Hall 740 Hillgrove Avenue, Western Springs, IL 60558

- A. **Call to Order**
- B. **Approval of Minutes**
- C. **Public Comment**
- D. **New Business**
 - 1. 2025 Referendum Scoping Studies — Pre-Final Findings
- E. **Other Business**
- F. **Adjournment**

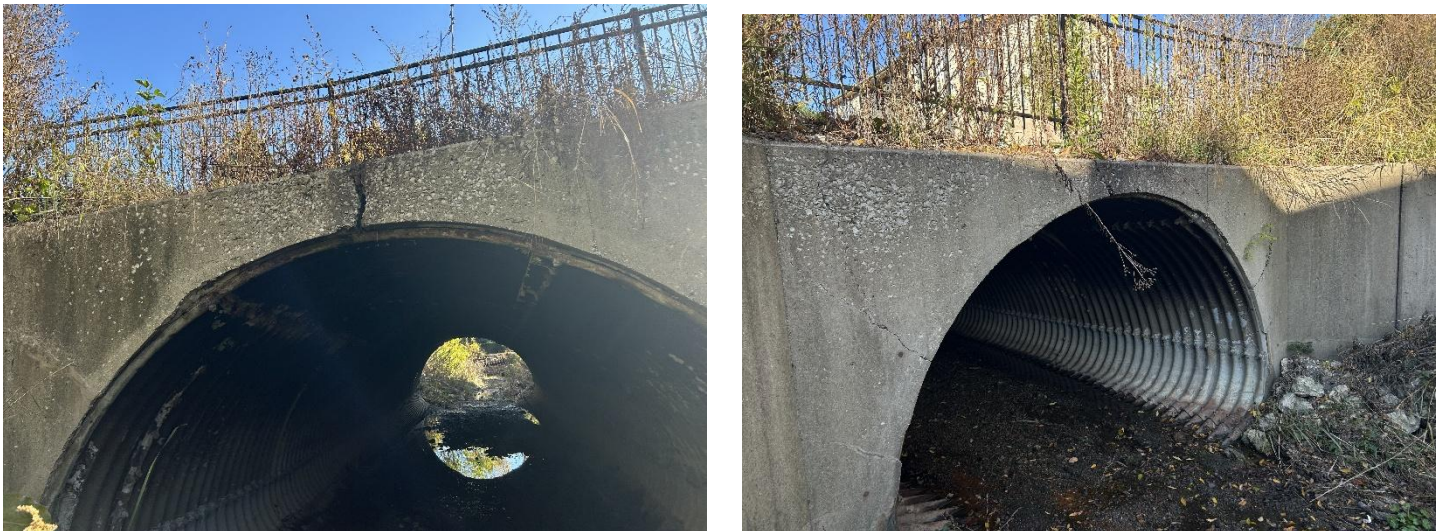
1. The west headwall was observed to be cracked in three locations and should be repaired
2. Riprap appears to be missing along the bank on the west side of Creek Drive, just north of the culvert. Consider reinforcing the bank with approximately 60 square feet of RR4 with RR1 bedding.

Figure 2: Existing CMP along 49th Street Ditch at the Creek Drive crossing appears to be in fair condition. Some cracking is visible along the west headwall.

The Village should confirm culvert ownership prior to completing the improvements.

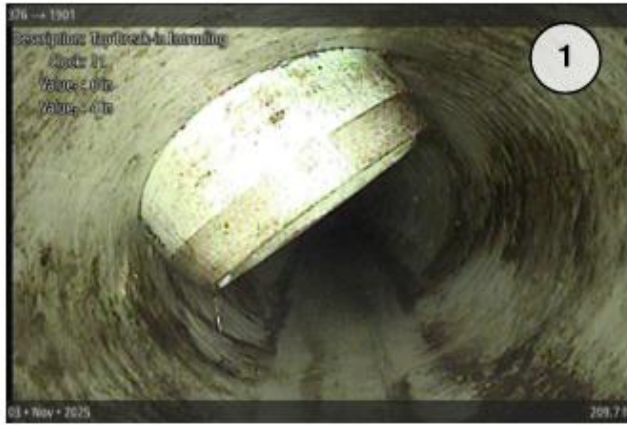
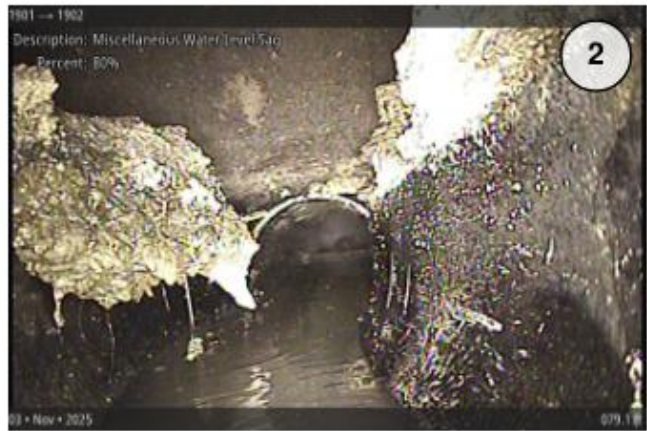
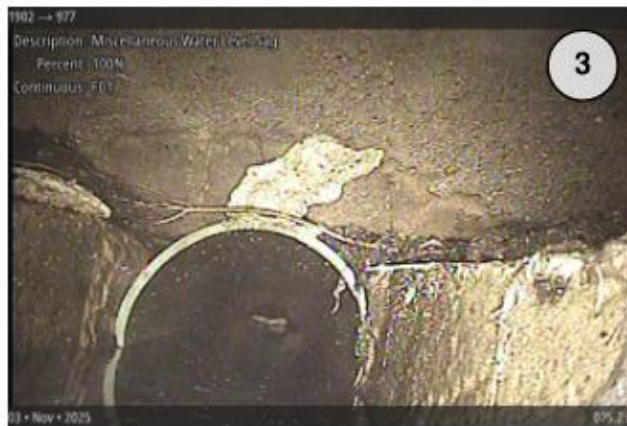
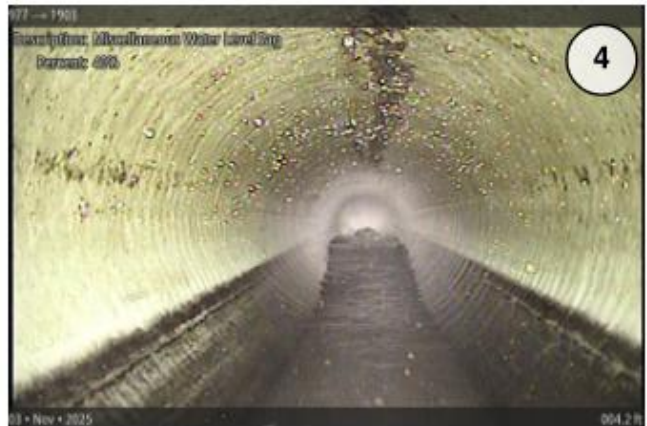
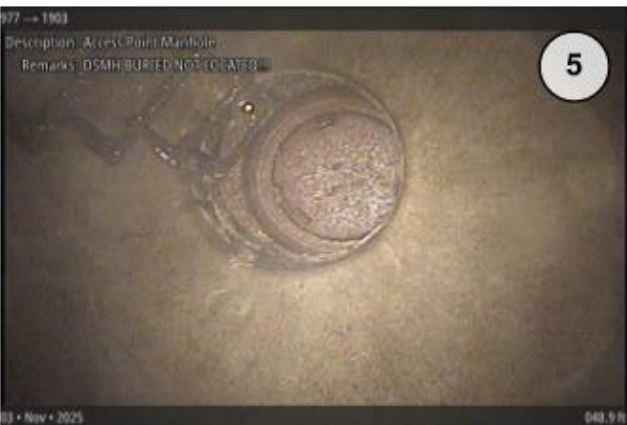
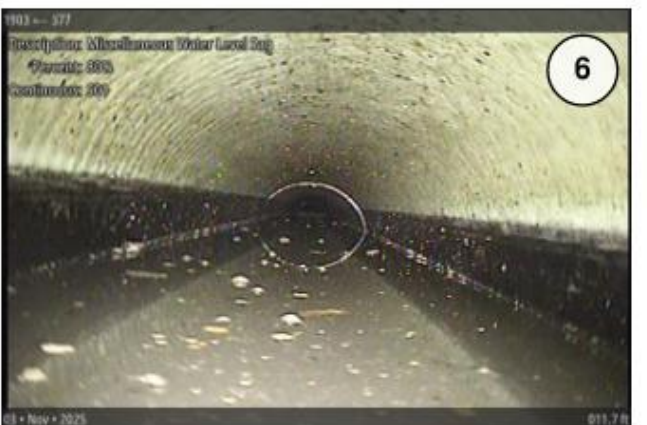
Figure 6: Corresponding photos showing sanitary sewer defects outlined in Table 6.

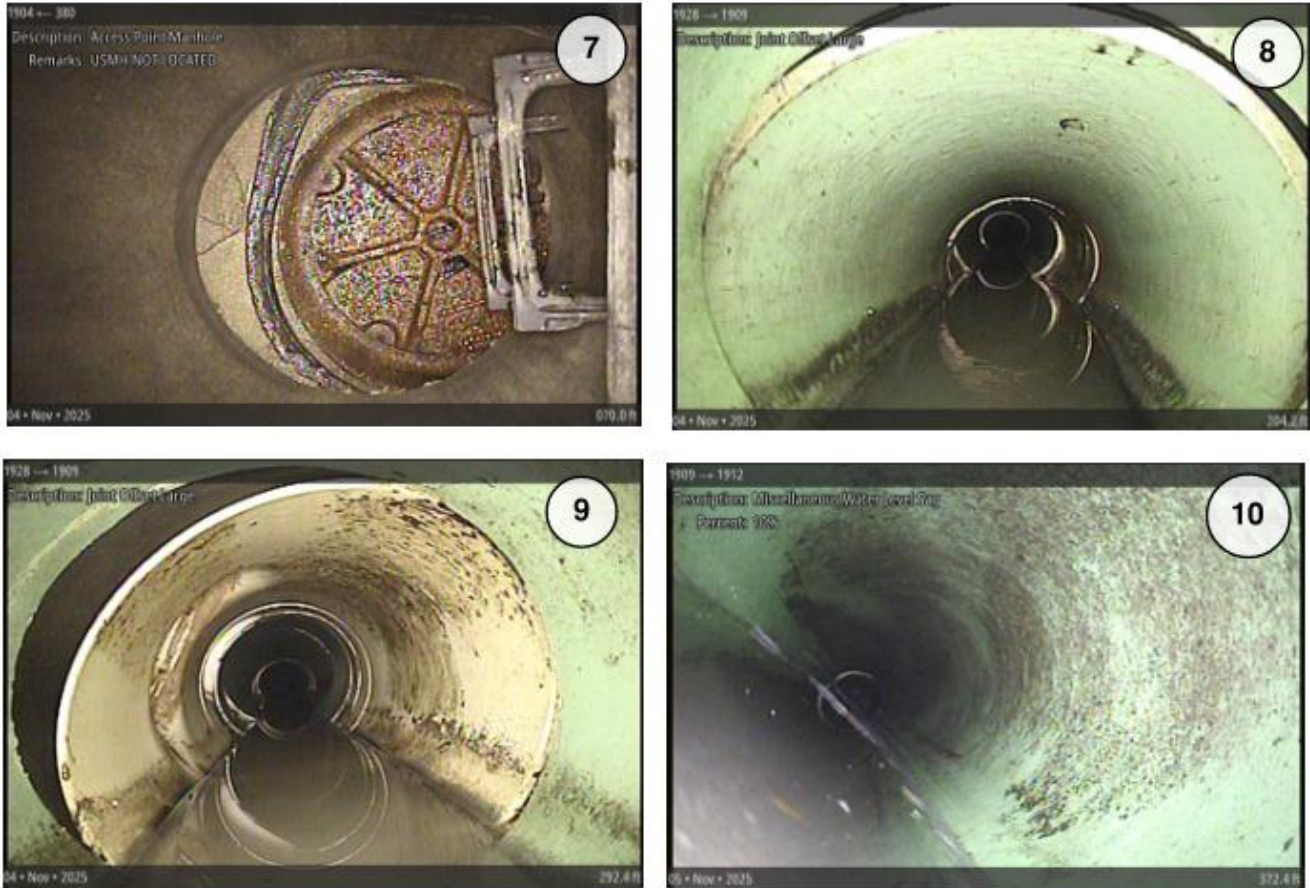
Phase 2 Sanitary Sewer Improvements			
Photo #	Sewer Location	Defect	Proposed Improvement
8	204 ft downstream of MH-1928	Large offset on sewer joint	Remove & replace ~4 LF of sewer; reconnect 1 sanitary service
9	292 ft downstream of MH-1928	Large offset on sewer joint	Remove & replace ~4 LF of sewer; reconnect 2 sanitary services
10	From 364 ft downstream of MH-1909 to MH-1912	Pipe sag; standing water in sewer	Remove & replace ~32 LF of sewer

Figure 7: Corresponding photos showing sanitary sewer defects outlined in Table 6 and 7.

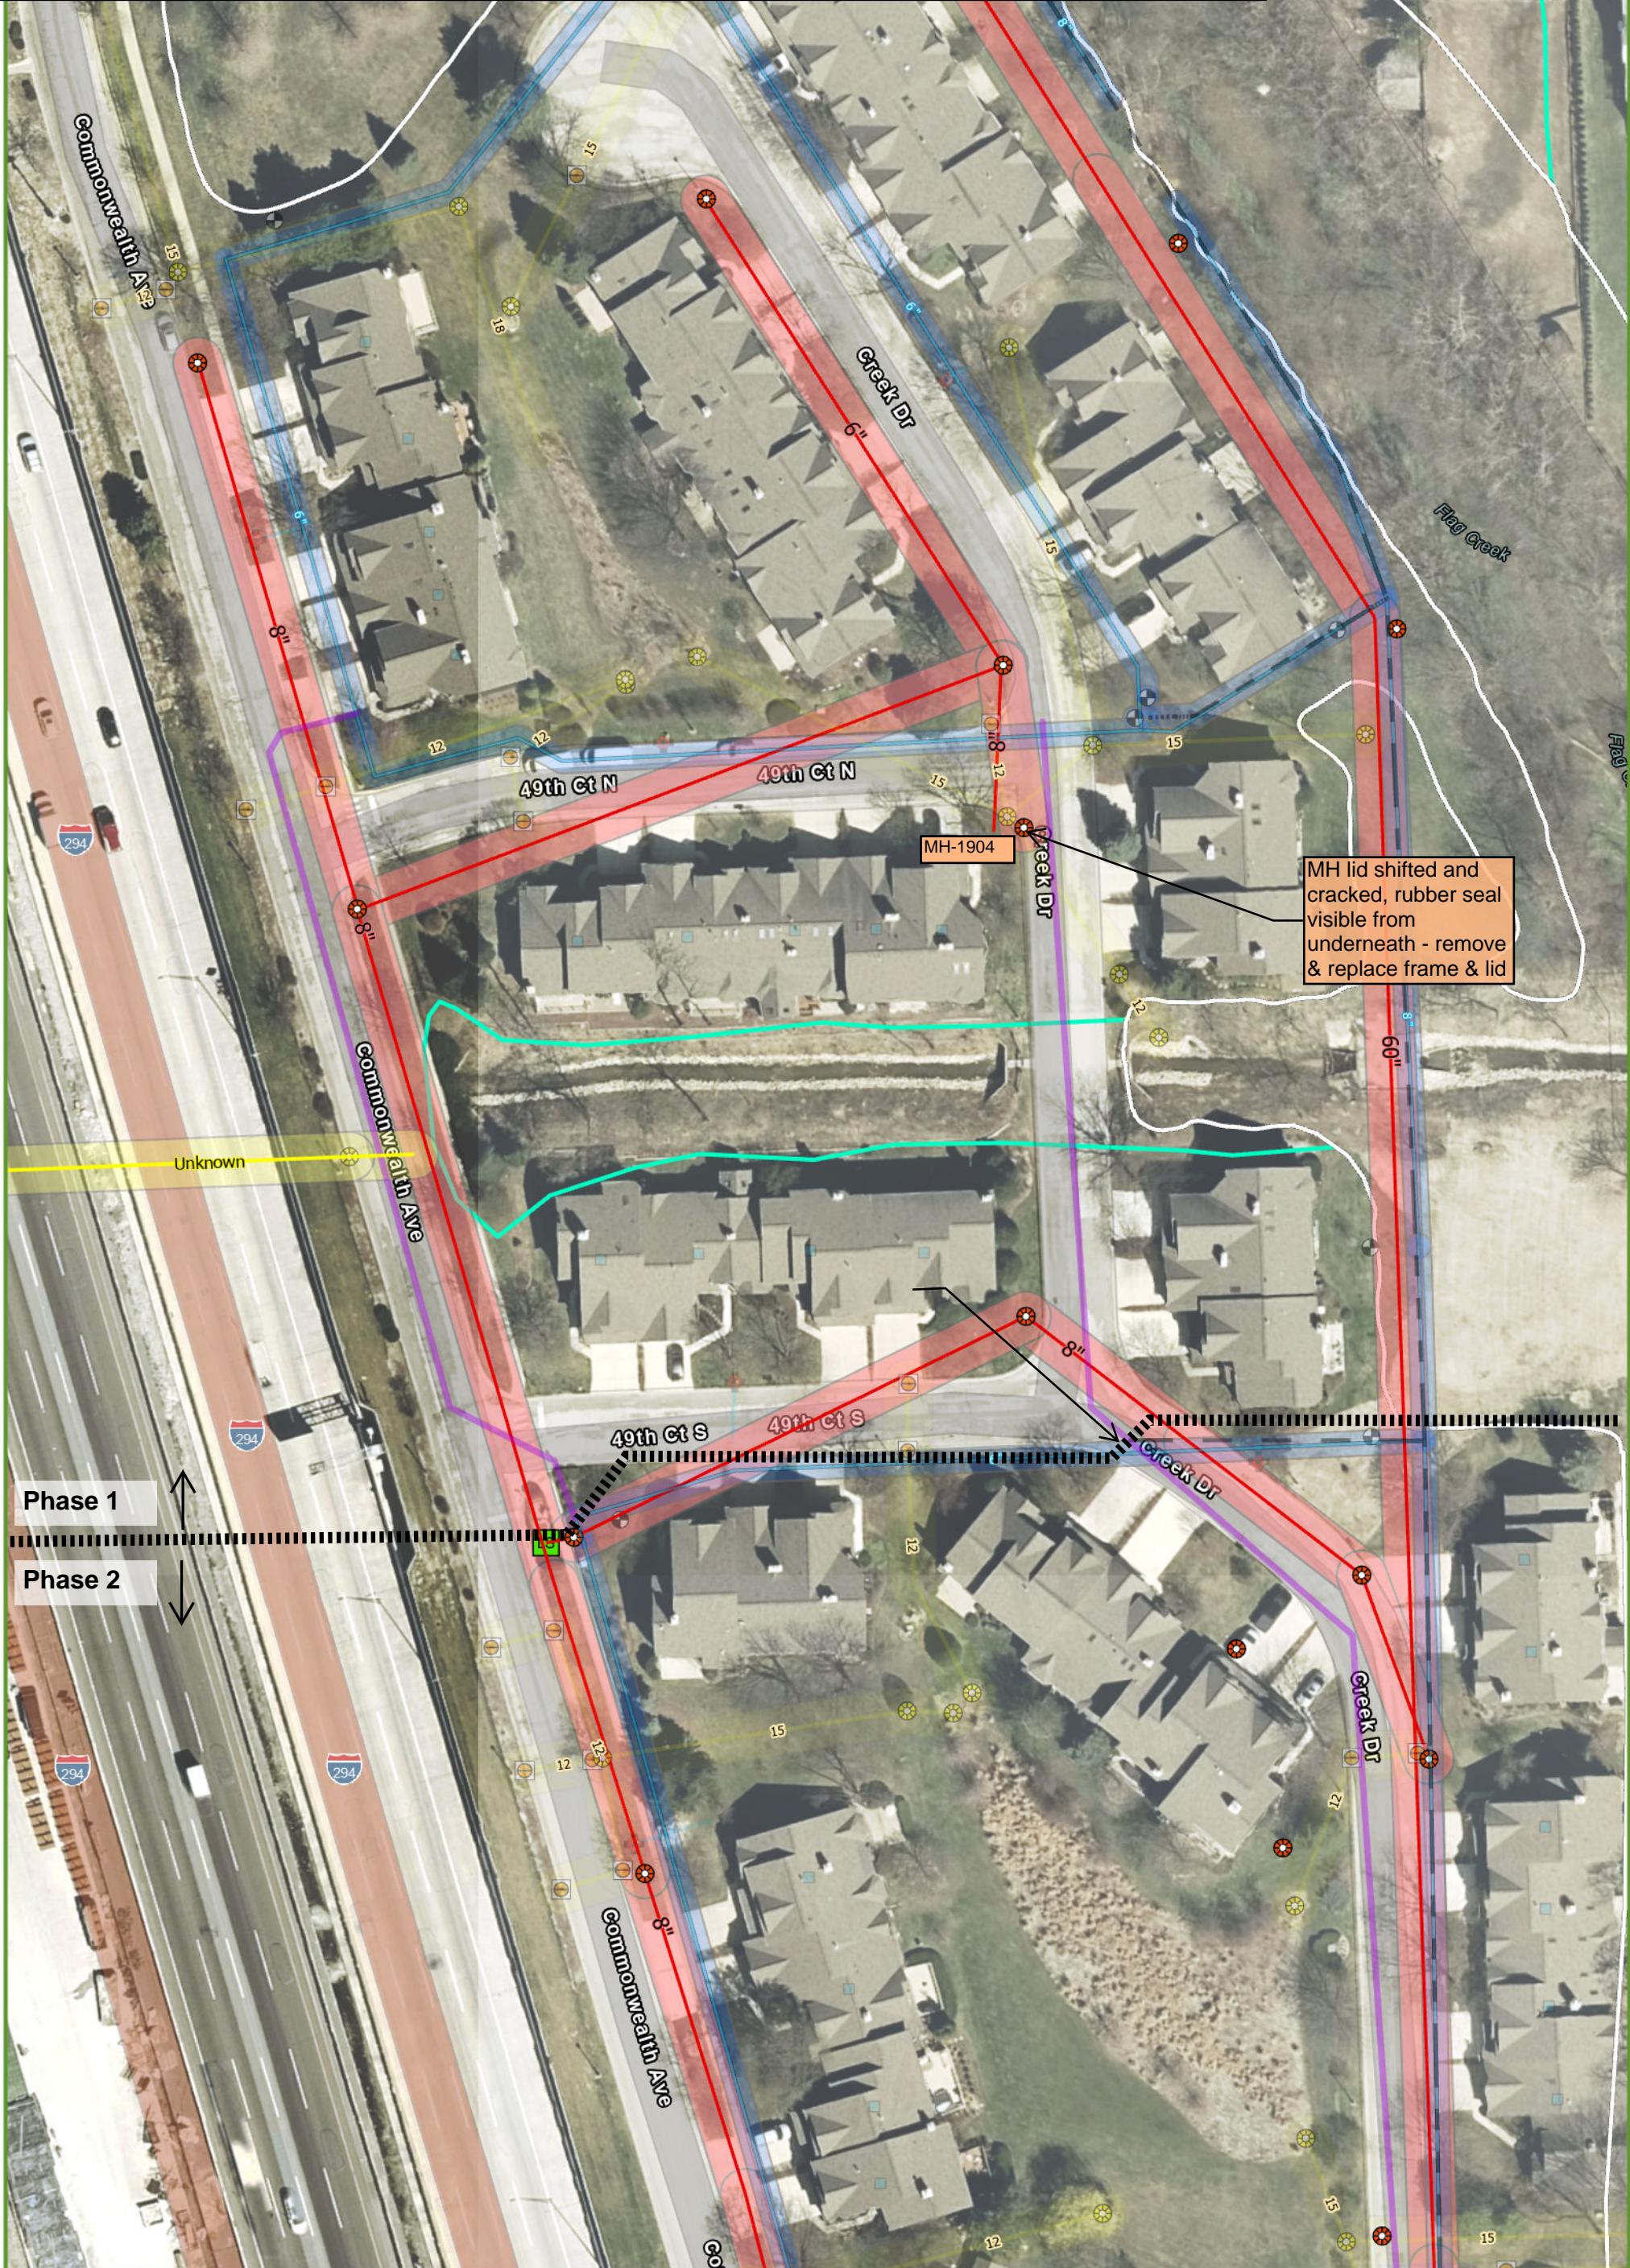
MH lid shifted and cracked, rubber seal visible from underneath - remove & replace frame & lid

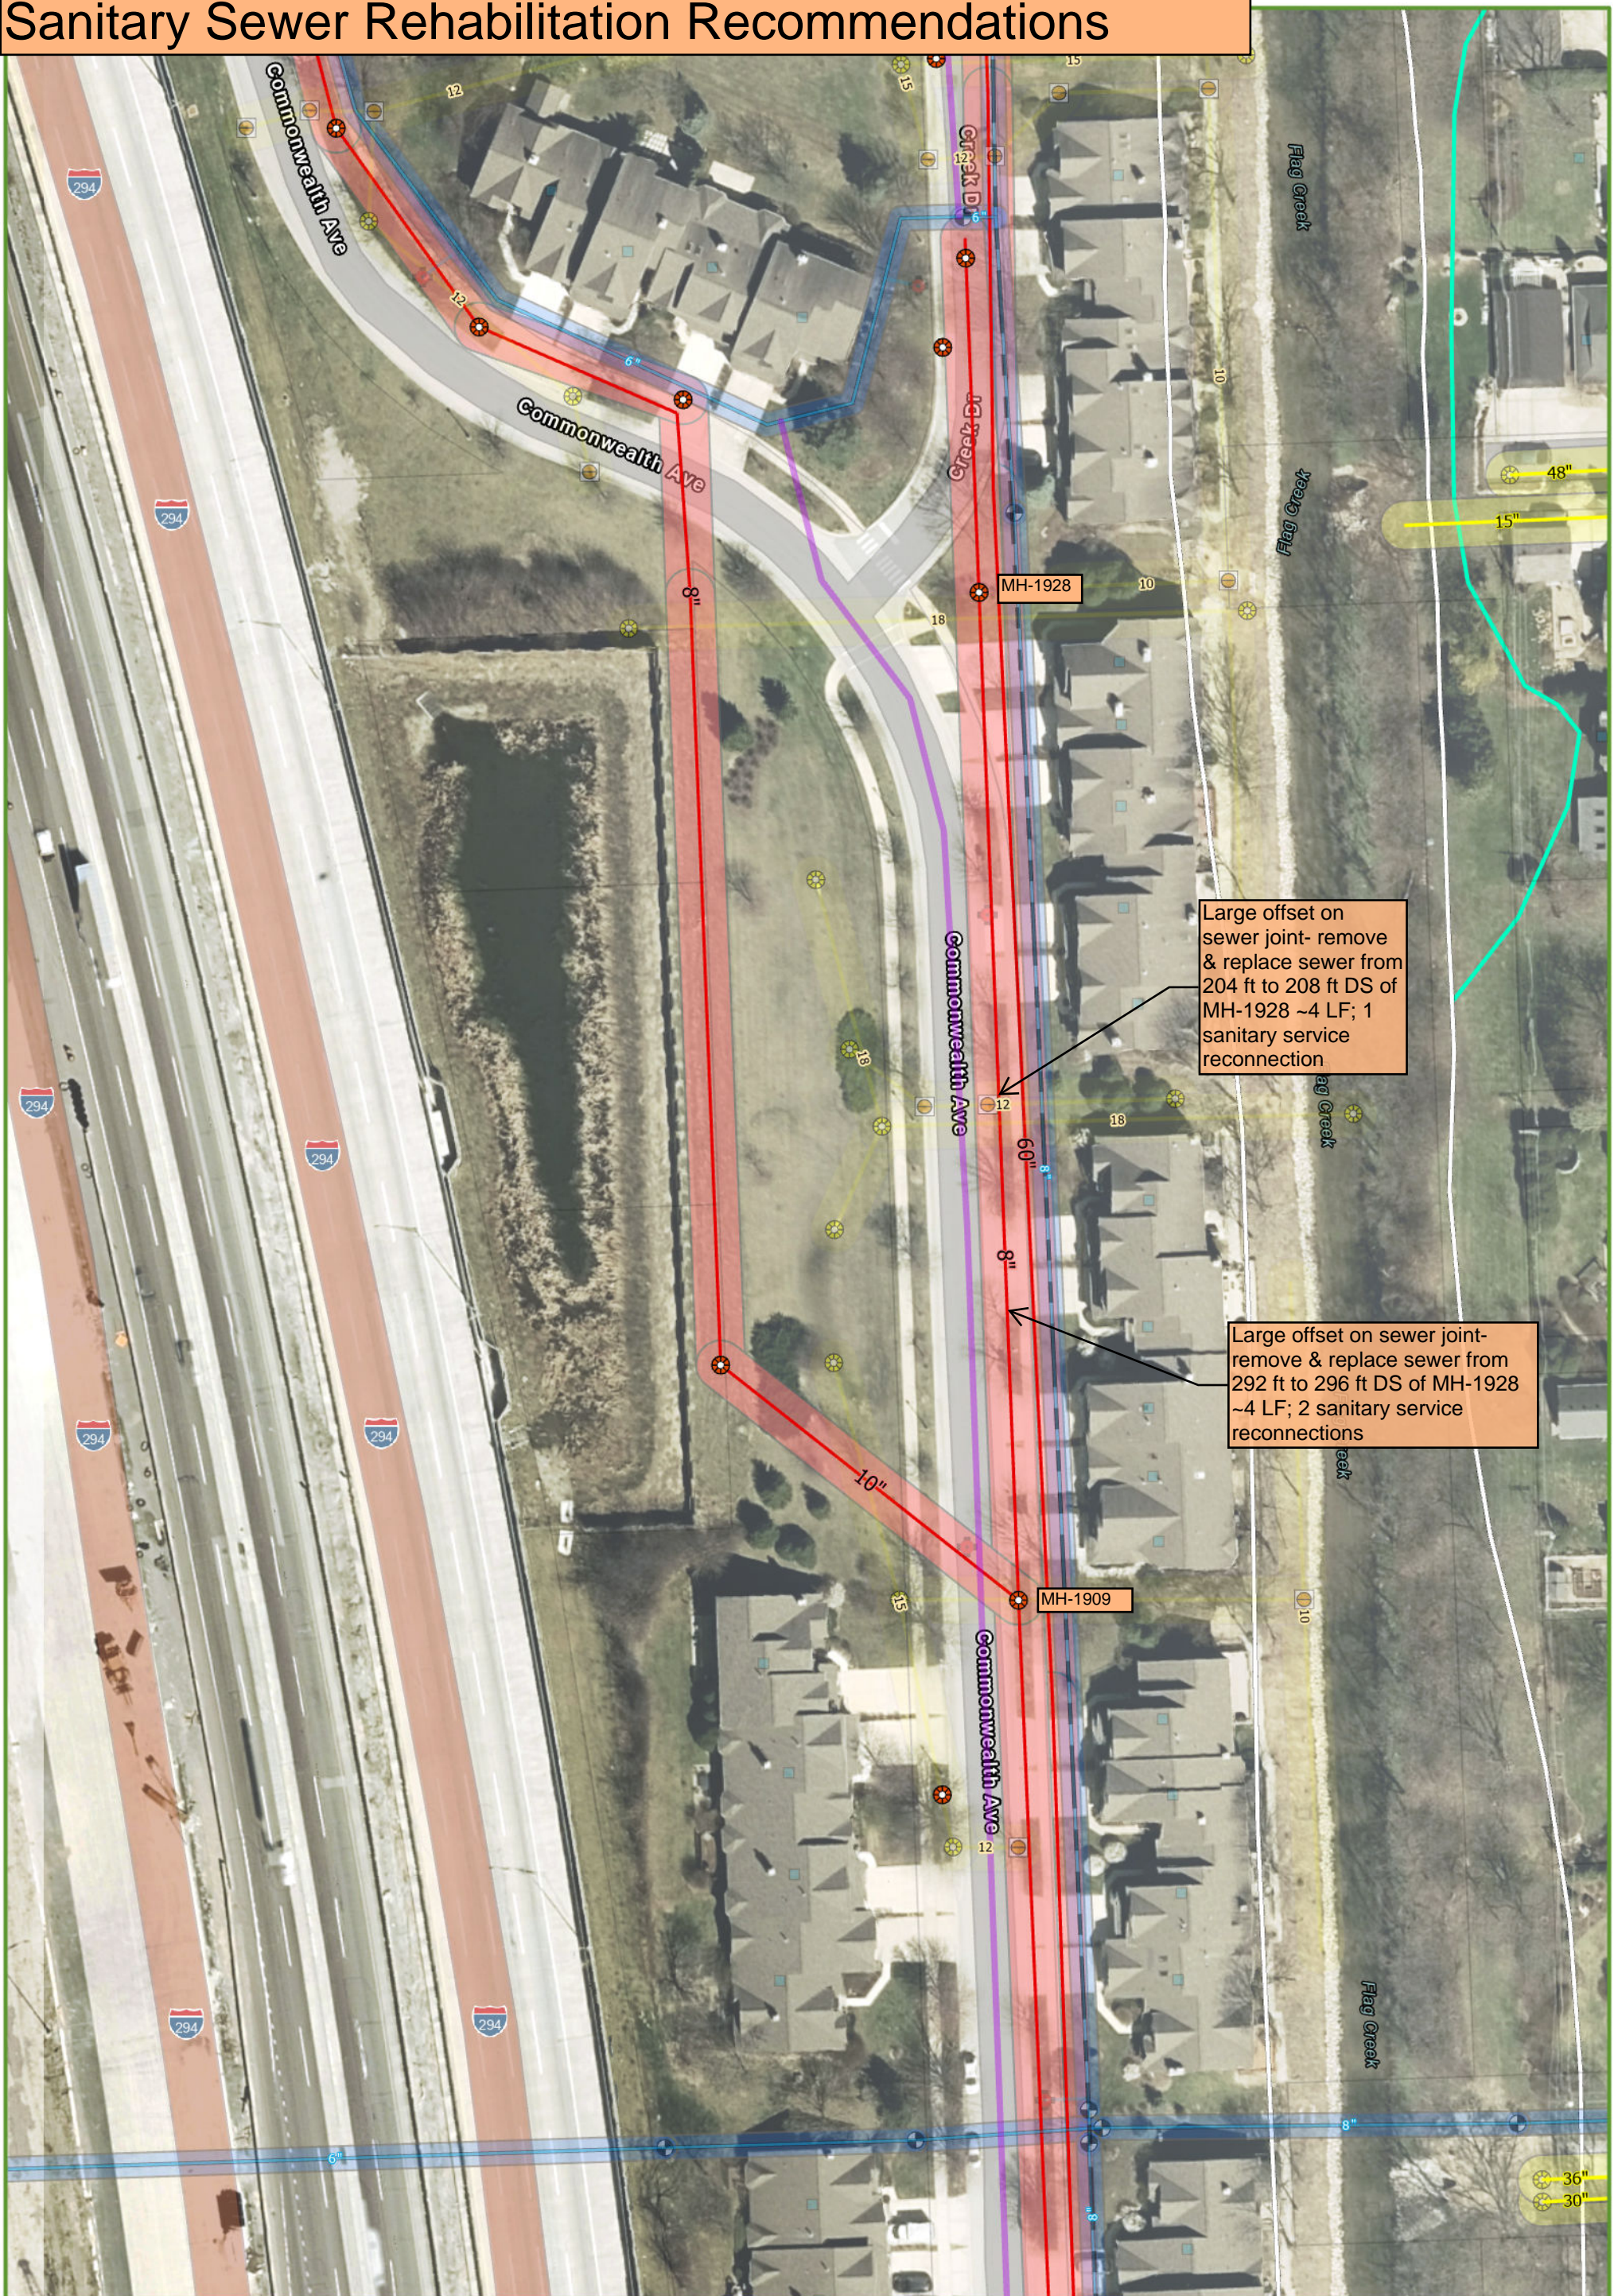
Large offset on sewer joint- remove & replace sewer from 204 ft to 208 ft DS of MH-1928 ~4 LF; 1 sanitary service reconnection

Large offset on sewer joint- remove & replace sewer from 292 ft to 296 ft DS of MH-1928 ~4 LF; 2 sanitary service reconnections

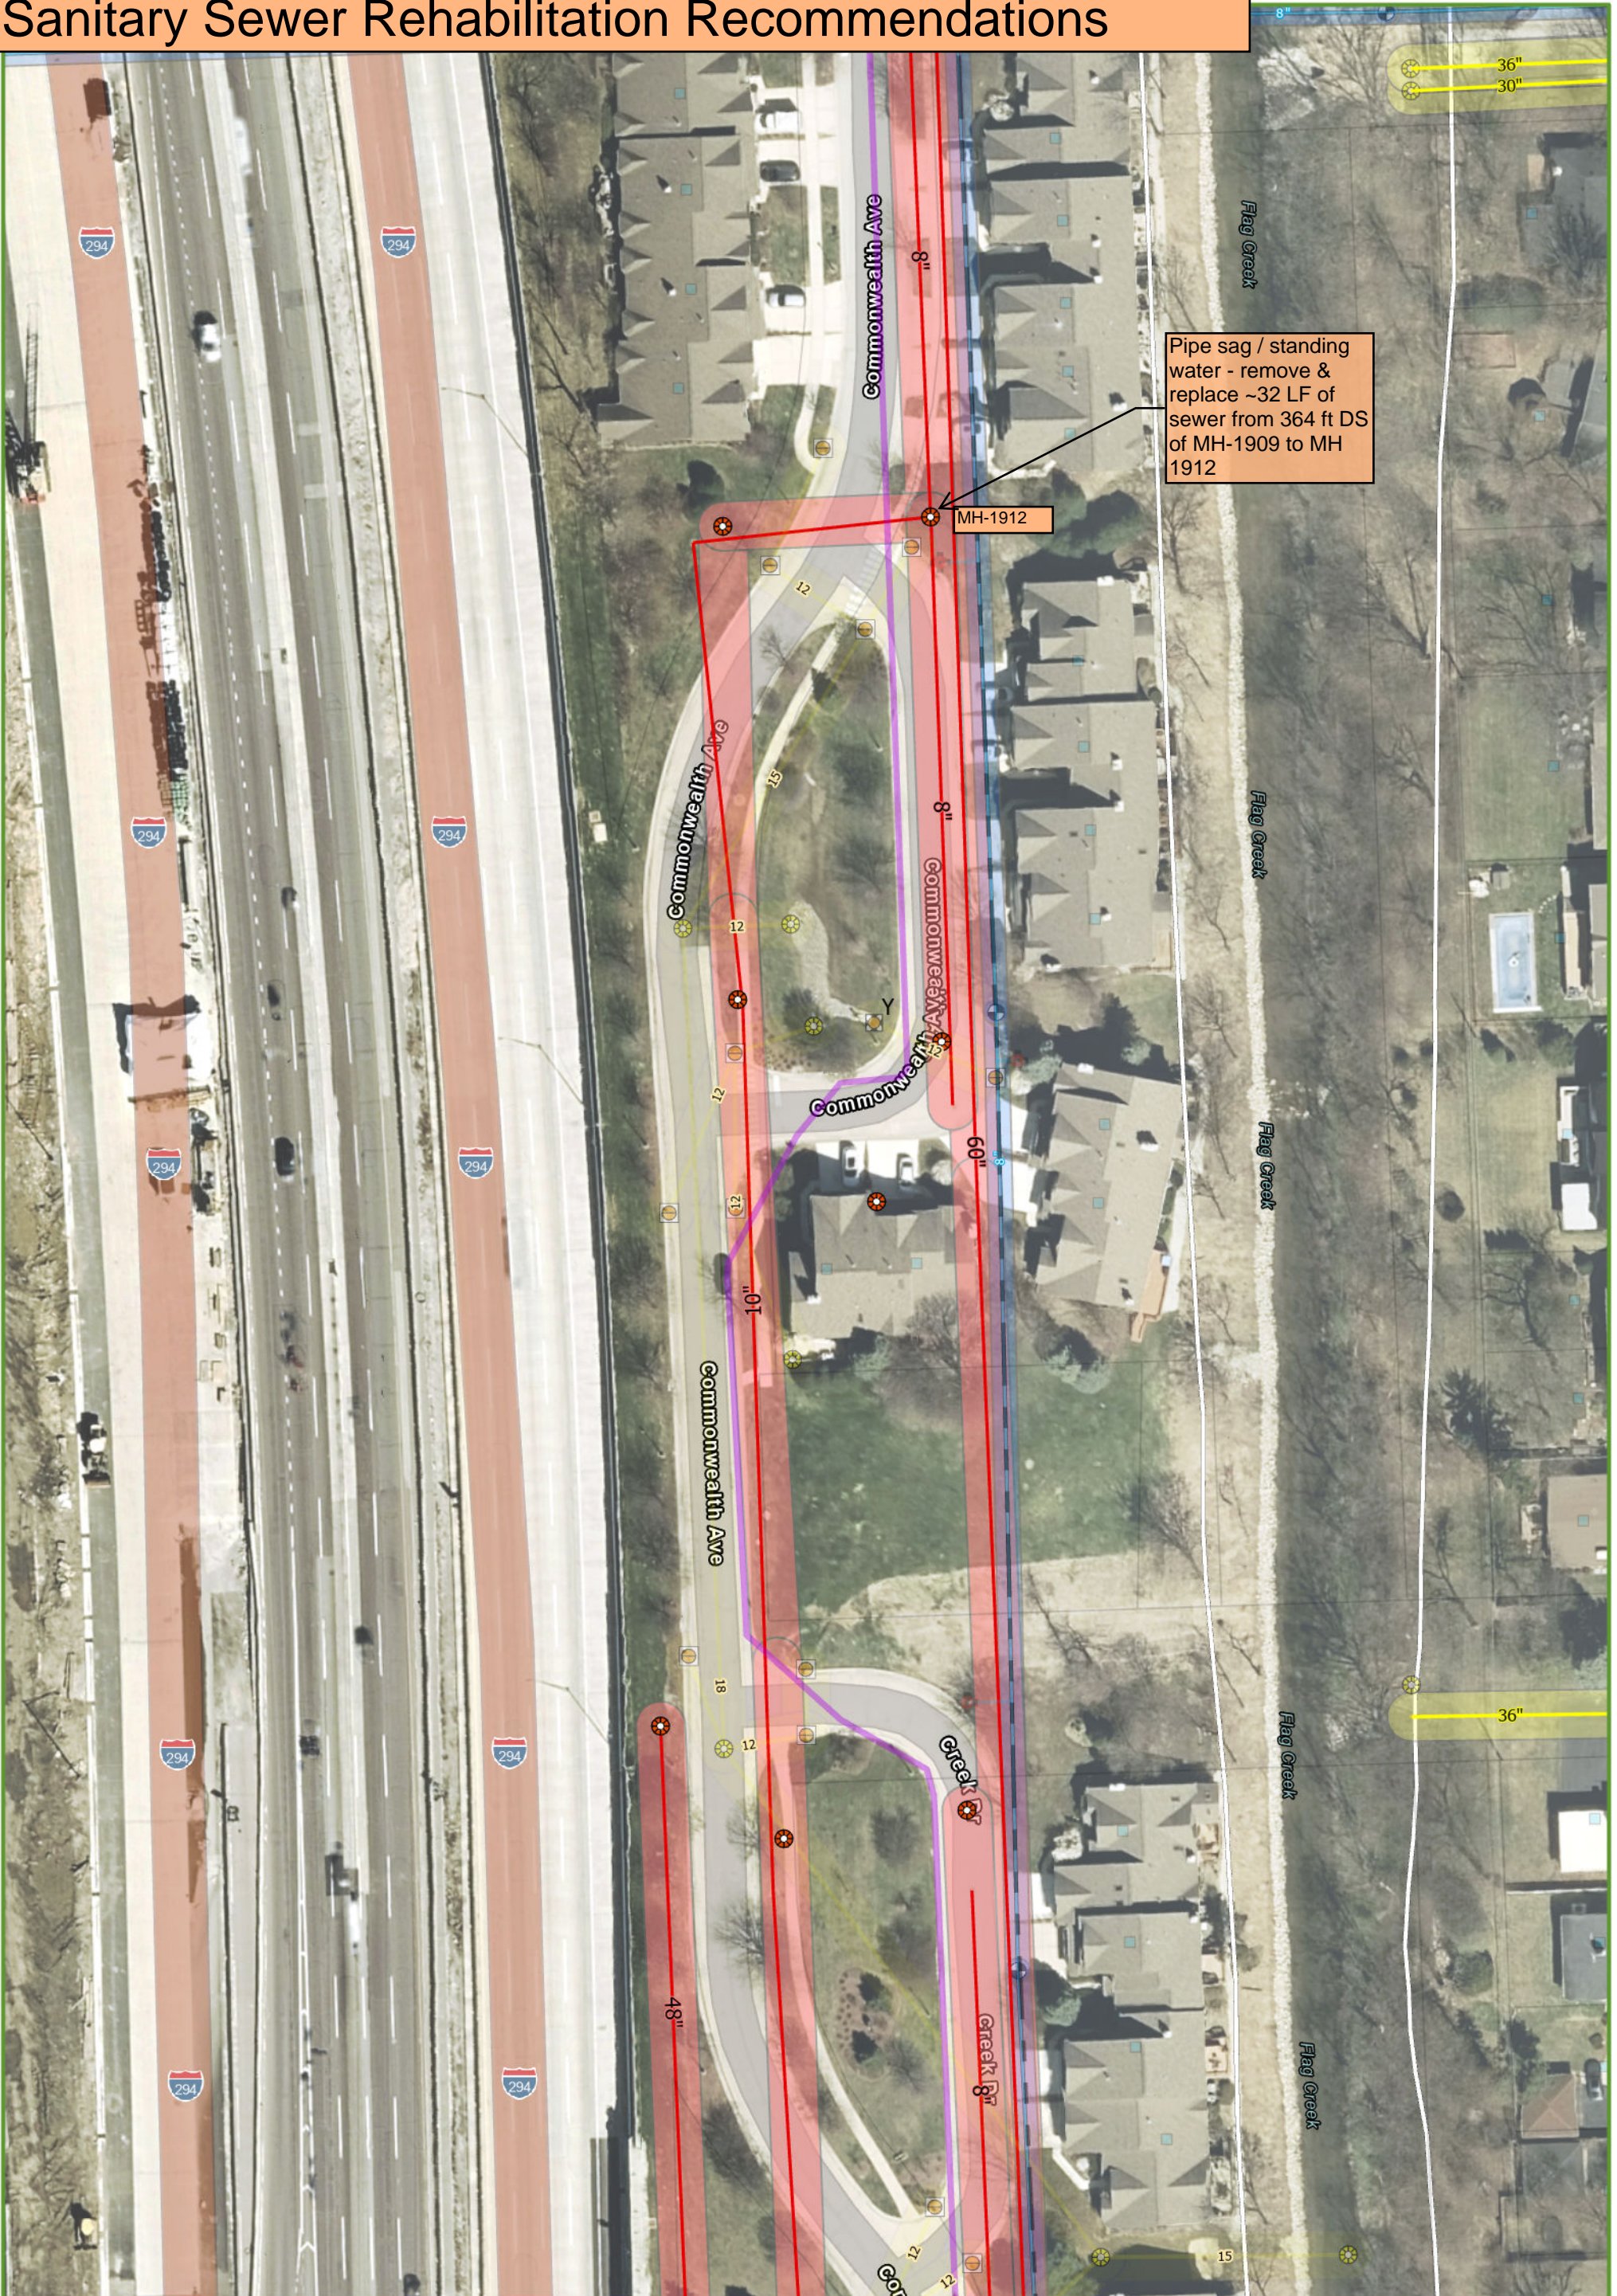
Pipe sag / standing water - remove & replace ~32 LF of sewer from 364 ft DS of MH-1909 to MH 1912

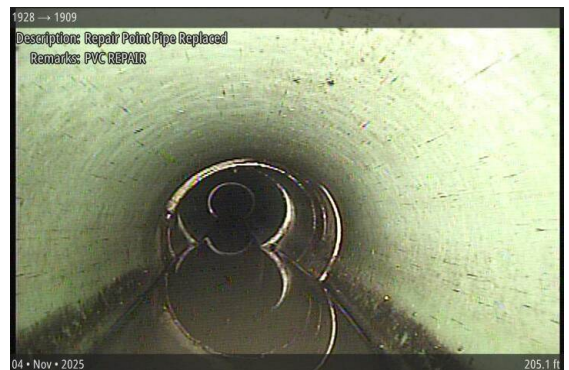
[Grade 4] Joint Offset Large at 204.2 ft

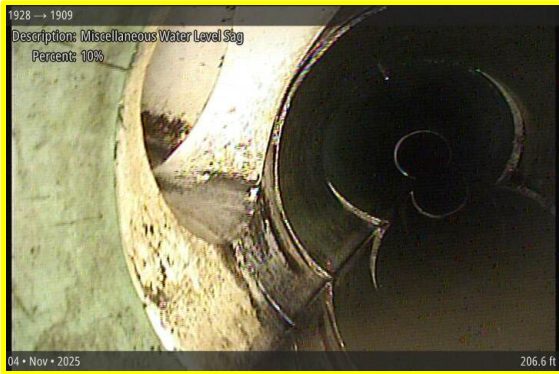
[Grade 2] Miscellaneous Water Level Sag at 206.5 ft

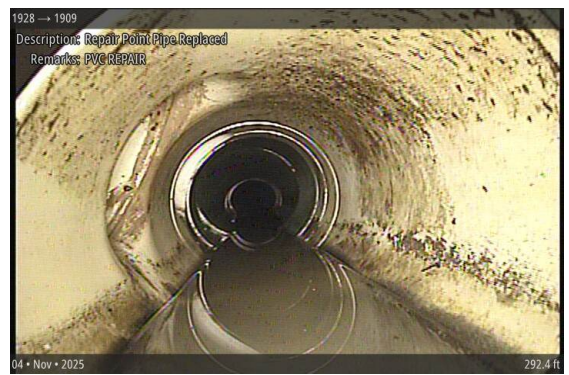
[Grade 4] Joint Offset Large at 292.4 ft
