INFRASTRUCTURE COMMISSION

Western Springs Water Treatment Plant Condition Assessment

TECHNICAL MEMORANDUM

ALTERNATIVES TO AMIAD IRON REMOVAL SYSTEM

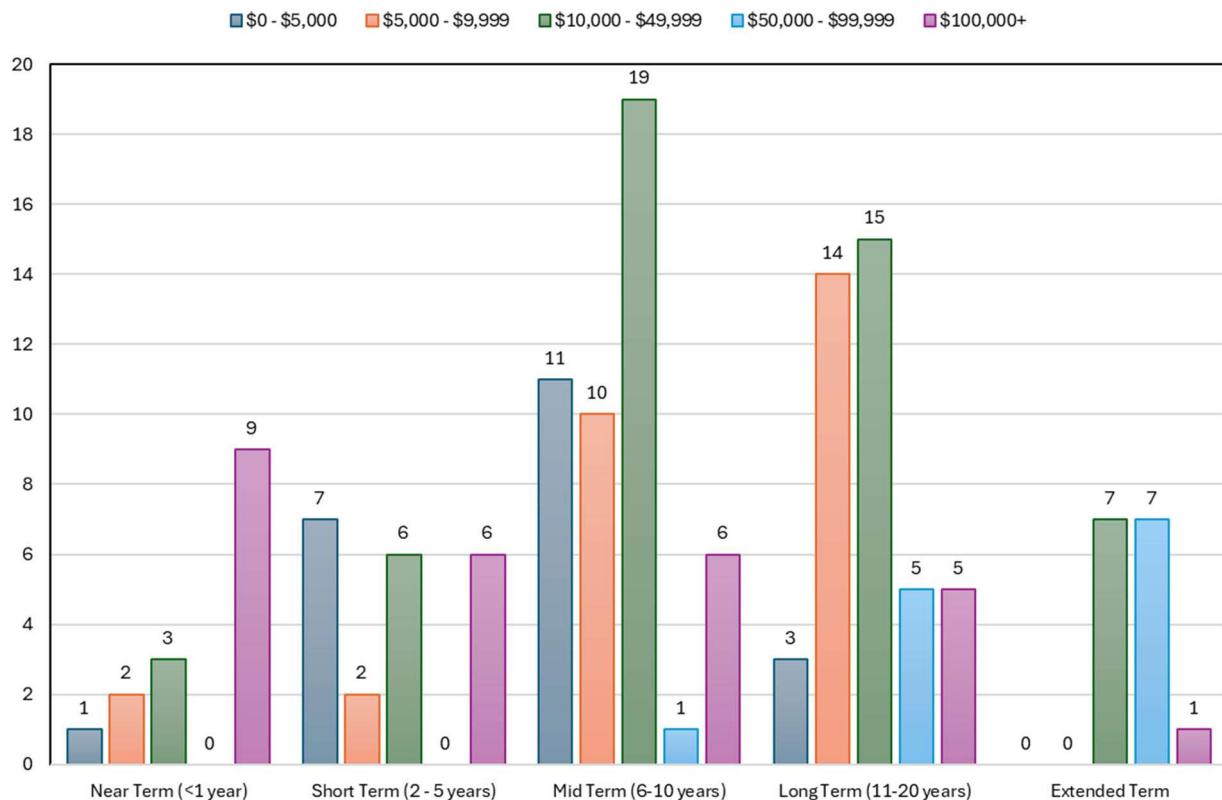
Figure 1 Asset Replacement Cost Distribution

Table 1 and Figure 1 provide an overview of the total number of assets and estimated costs considered in future planning. Detailed breakdowns by timeframe are presented in Tables 2 through 5. Summaries of the condition of each asset can be found in Attachment A.

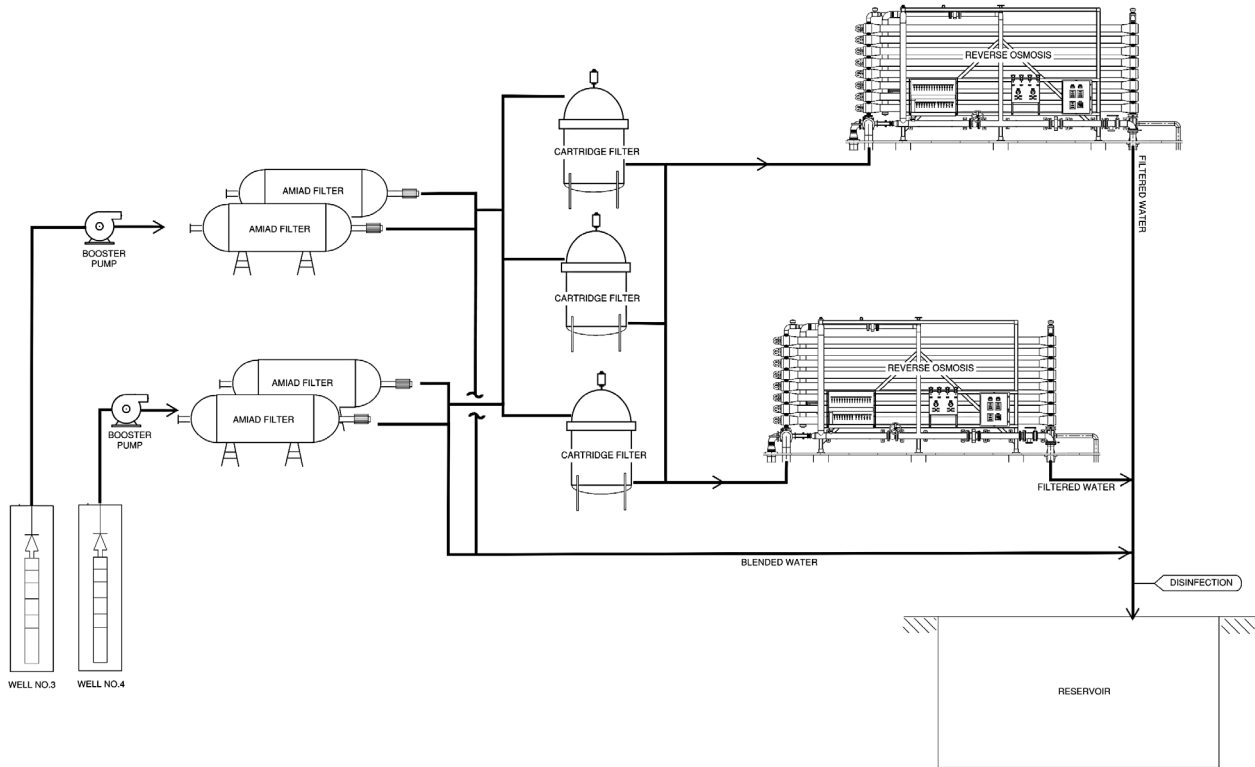
Figure 1 Process Flow Diagram VoWS Western Springs Water System

The remaining untreated raw water bypasses the treatment process and is blended with the treated (filtered) water downstream in a common header. This blended stream is then disinfected and stored in a 500,000-gallon finished water reservoir. Figure 1 illustrates the process flow of the VoWS water production system. The following sub-sections provide technical overviews of the main processes in the treatment plant.

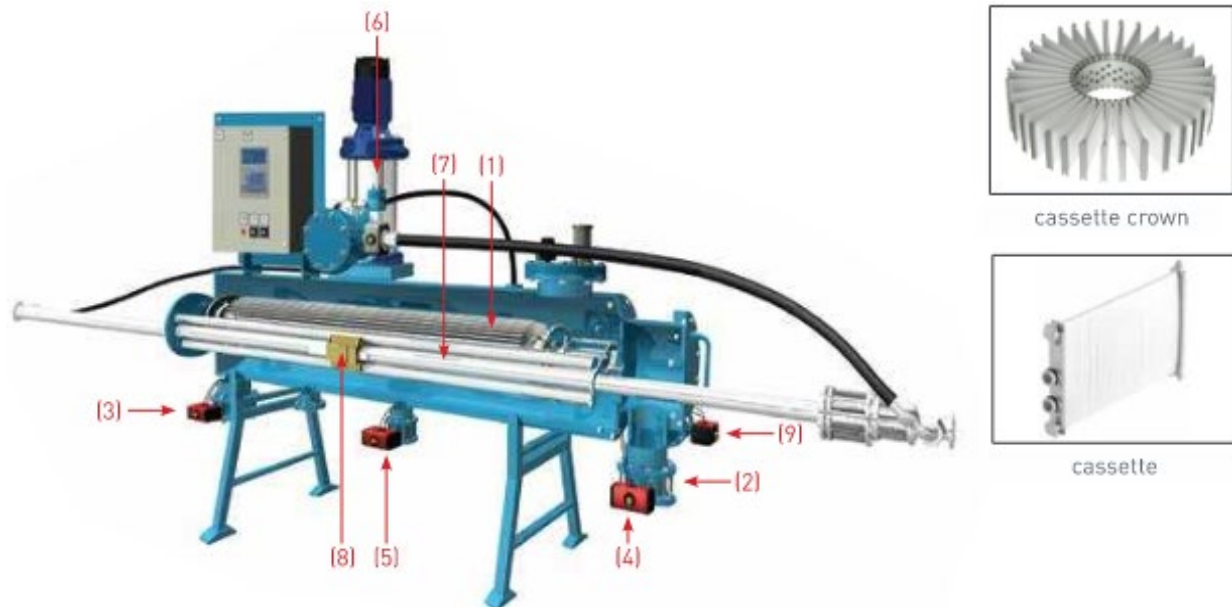
Figure 2 Illustration of Existing Amiad AMF-370K Filter Process Components

As described above, filtration is non-continuous during the backwash cycle. The system currently requires one to two backwashes a day, with each cycle taking about 30 minutes to complete. Clean-in-place cleaning is conducted every 5 weeks, which includes 1 hour of soaking with heated oxalic acid (100 degrees Fahrenheit) followed with 1.5 hours of recirculation, and 30 minutes of flushing. The system uses pneumatic actuated valves, which are currently the sole users of the compressor in the treatment plant.

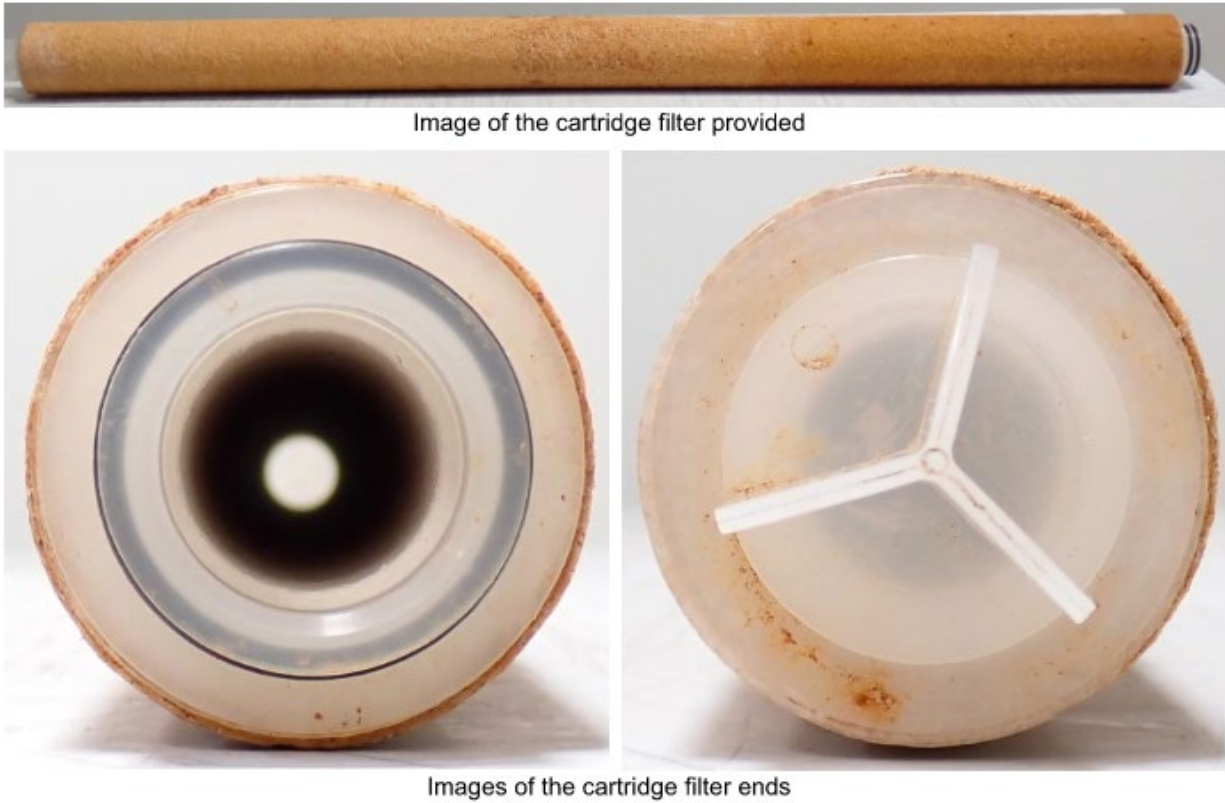
Figure 3 Cartridge Filter Exhibiting Orange-Colored Foulant Exterior Surface

The cartridge filter (Figure 3) displayed external fouling characterized by an orange-colored, fine-granular substance, which was more concentrated on one end. Despite the external buildup, the internal filter fibers remained unaffected, as the foulant did not penetrate into the core structure. Advanced imaging techniques, including Chromatic Elemental Imaging (CEISM) and Energy Dispersive Spectroscopy (EDS), identified iron and bio-slime as the primary foulants. Elemental analysis showed that iron was the most abundant component at 30.86 percent by weight, followed closely by carbon and oxygen. Lesser amounts (<10 percent) of phosphorous, calcium, silicon, and magnesium were also present. Refer to Appendix B for Avista's Cartridge Filter Analysis Report.

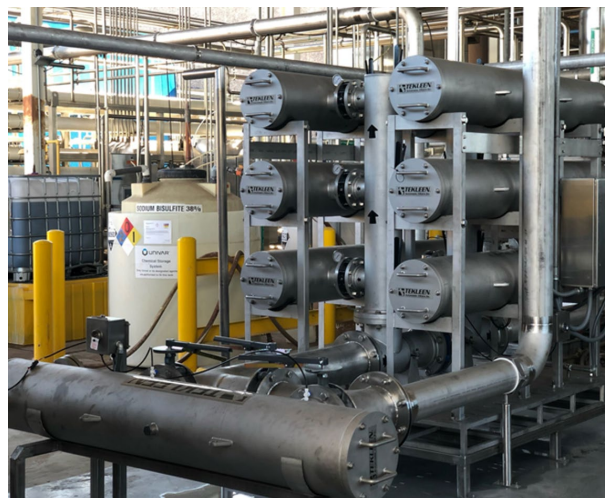
Figure 5 Typical Configuration Stacked Filters (Tekleen, Arizona)

For high-production applications, multiple filters can be stacked vertically and connected to a common inlet header to minimize overall system footprint. Each filter is equipped with a dedicated inlet and outlet that can be fitted with isolating valves. This configuration allows operators to adjust the number of filters in operation based on real-time water quality conditions and flow demands. It also enables individual units to be taken offline for maintenance or inspection without interrupting overall system production, thereby enhancing operational flexibility and system reliability. Figure 5 depicts a Tekleen installation for Pepsi in Arizona.

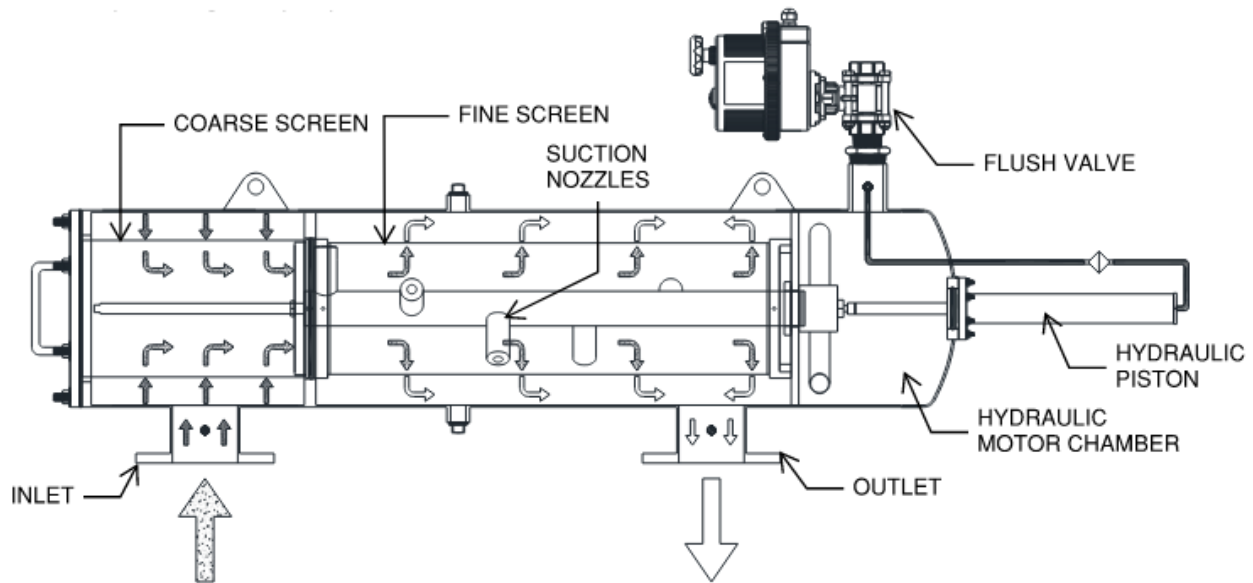
Figure 6 Main Components and Flow Path of Self-Cleaning Filter

When the differential pressure reaches a predefined setpoint, or a programmed time interval, the system automatically triggers a self-cleaning backwash cycle. This process begins with the opening of the flush valve, which causes a rapid drop in pressure within the hydraulic motor chamber. This pressure drop creates a localized low-pressure zone (vacuum) inside the particle remover assembly, enabling the system to effectively dislodge and extract the debris adhering to the fine screen. Backwash waste is drawn through a series of suction nozzles, which are mounted on a rotating scanning arm driven by the hydraulic motor. Figure 6 highlights the main components of the filter and flow direction during normal operation.

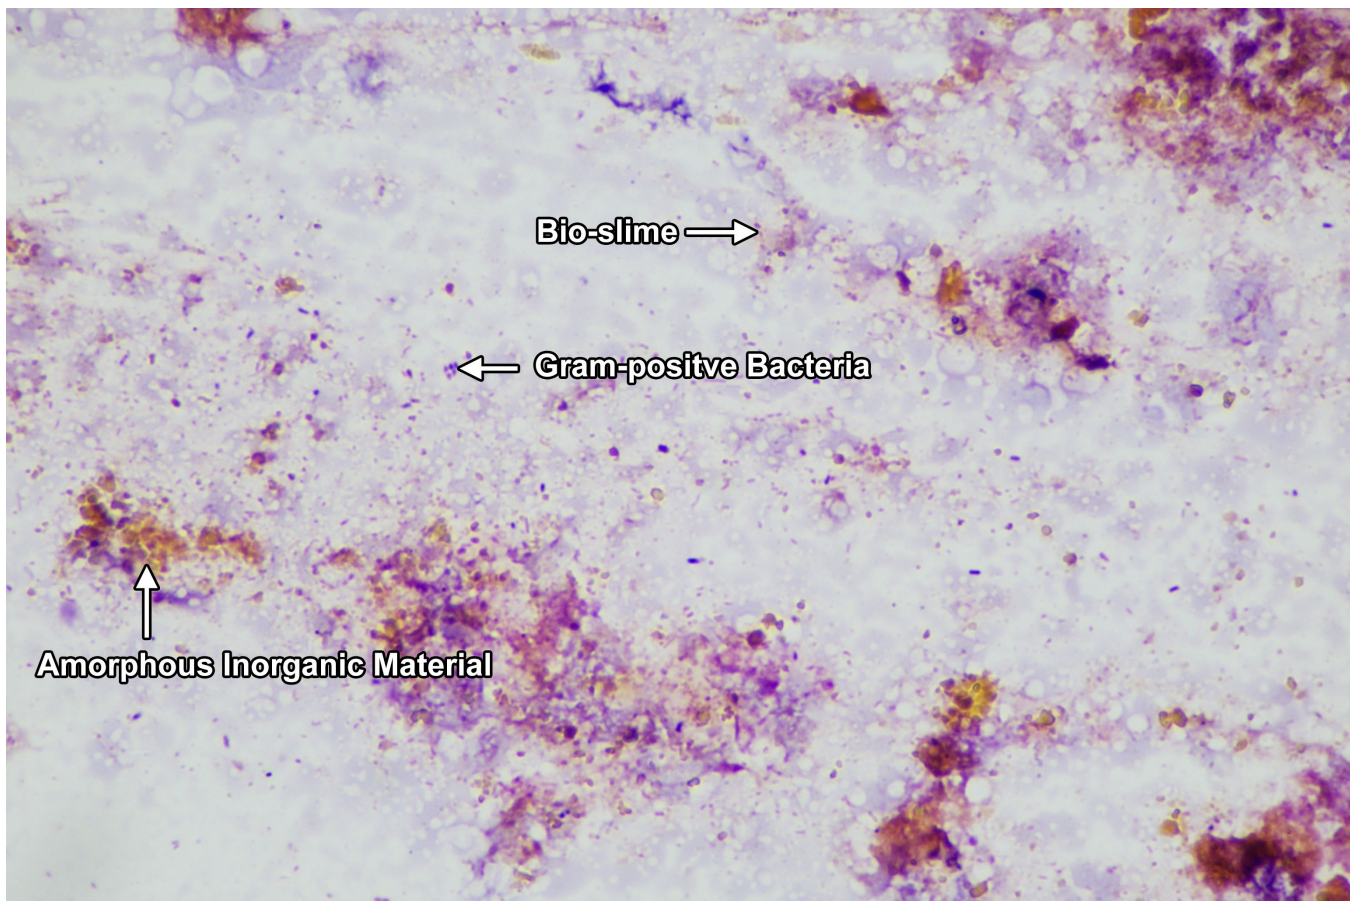
◆ **Results:** Microscope analysis of the scrapable foulant material displayed amorphous inorganic deposits, bio-slime, translucent crystals, and Gram-positive bacteria.

Light microscope image (1000x) of the scrapable foulant from the cartridge filter

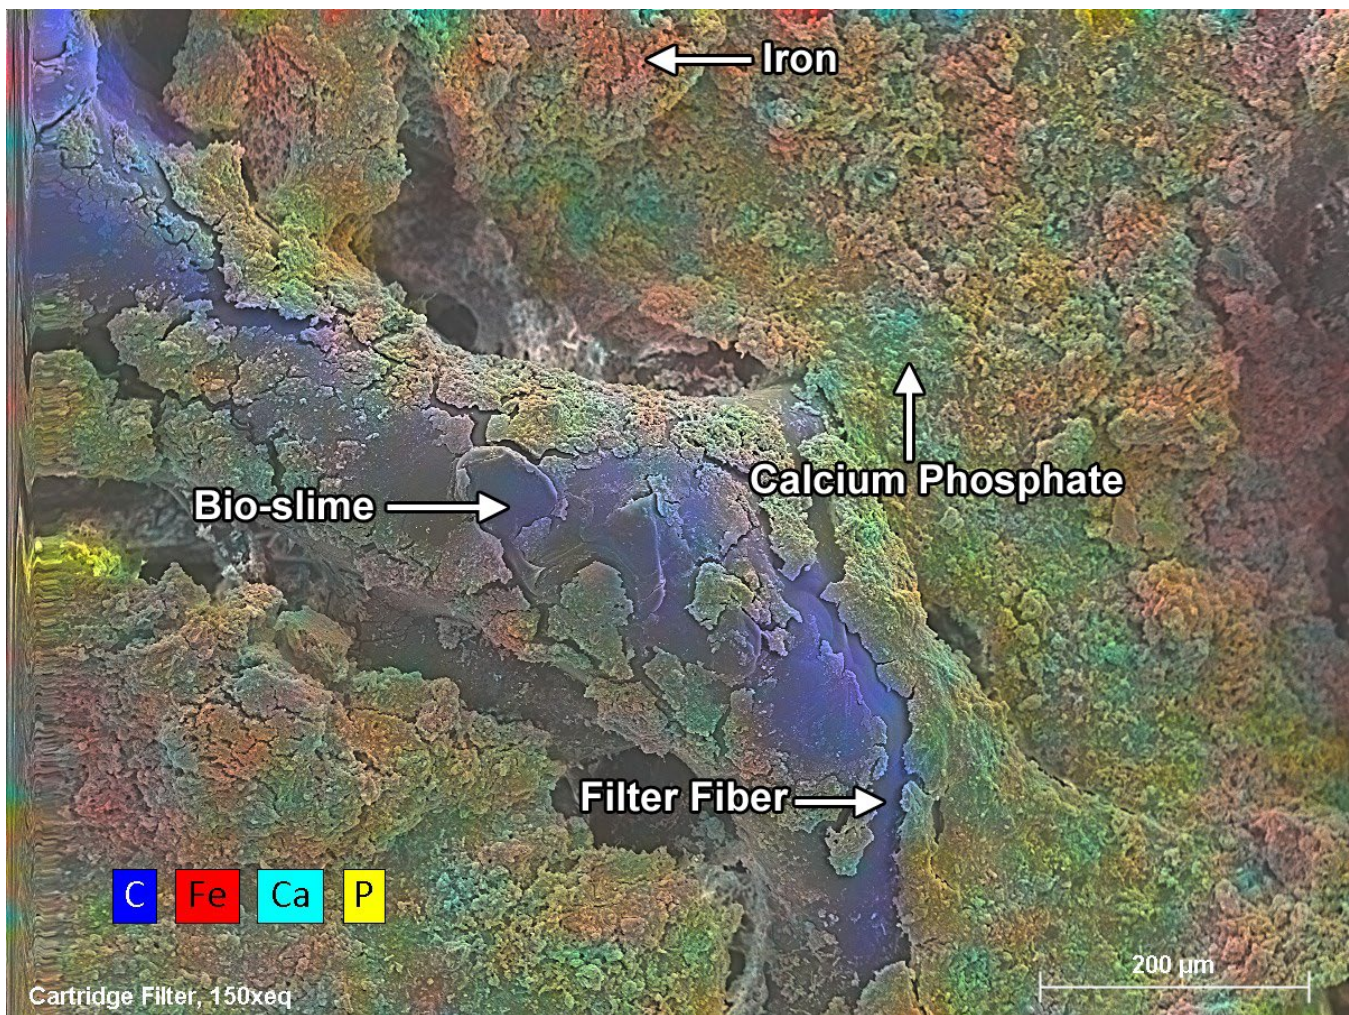
◆ **Results:** CEI of the filter exteriors revealed the presence of iron (red) coating the filter fibers. Deposits of calcium phosphate (green, caused by mixture of light blue and yellow) and bio-slime (smooth material composed of carbon – dark blue) were also observed. The cartridge filter fibers (carbon – dark blue) were visible beneath and between the foulant layer.

CEI image (150x) of the cartridge filter exterior with labels

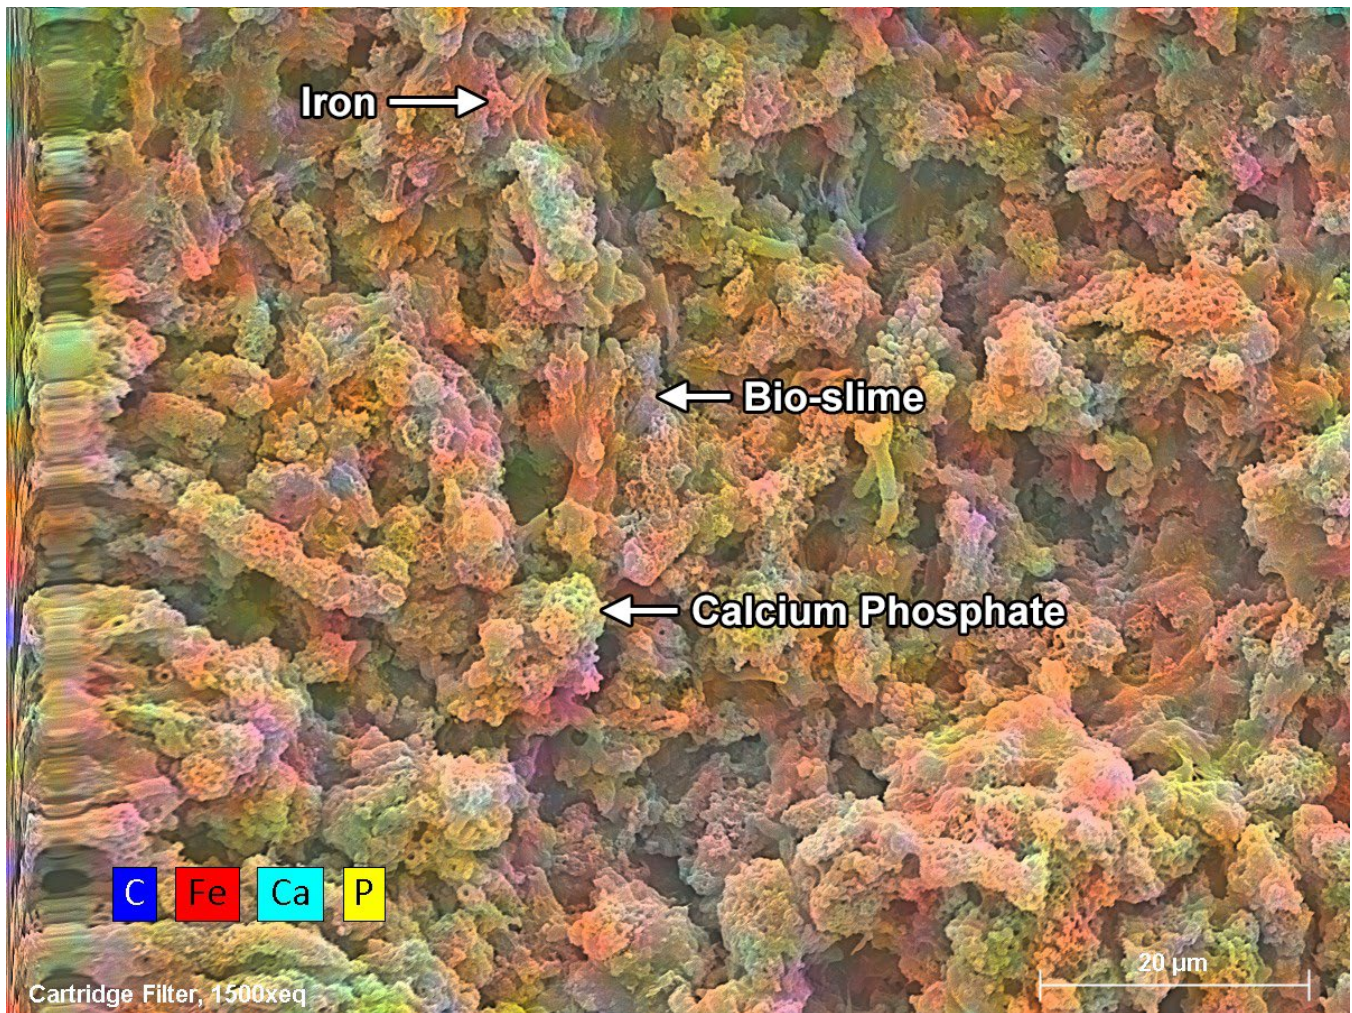
CEI image (1500x) of the cartridge filter exterior with labels

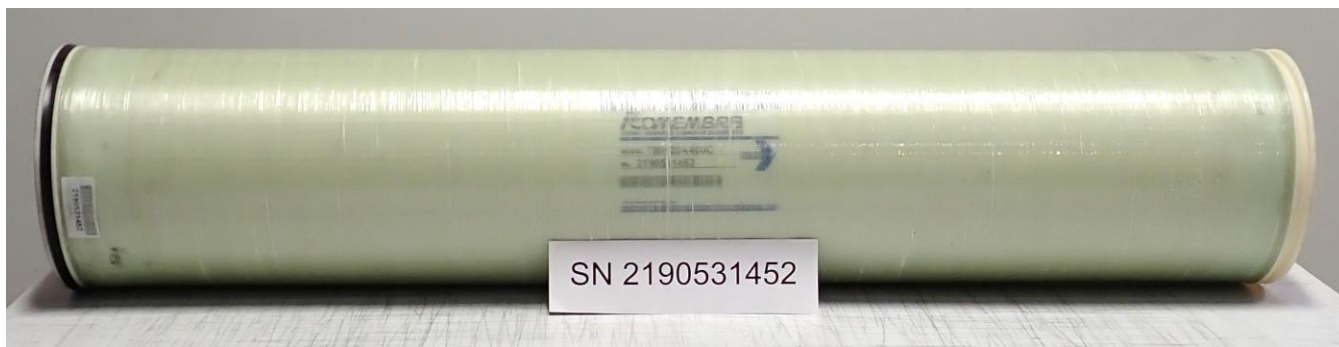
Results: The fiberglass casing was in good mechanical condition.

Fiberglass casing of SN 2190531452

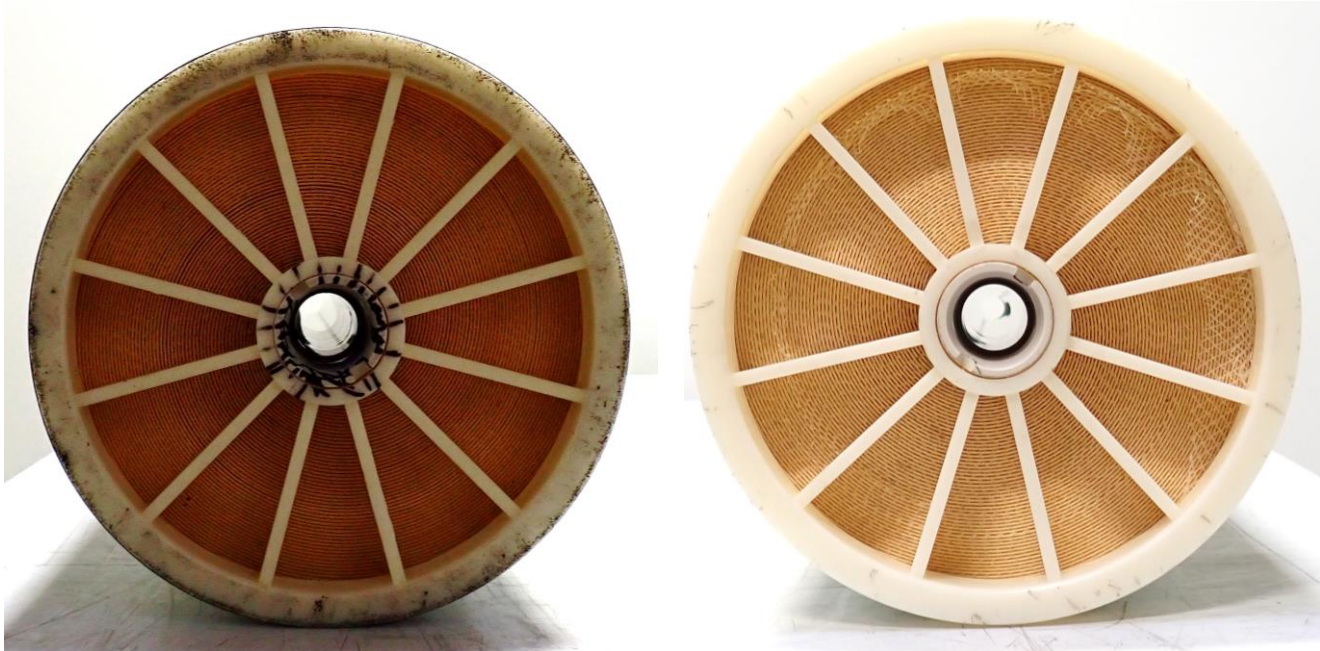
Results: The ATDs were in good physical condition.

Feed (left) and concentrate (right) ATDs of SN 2190531452

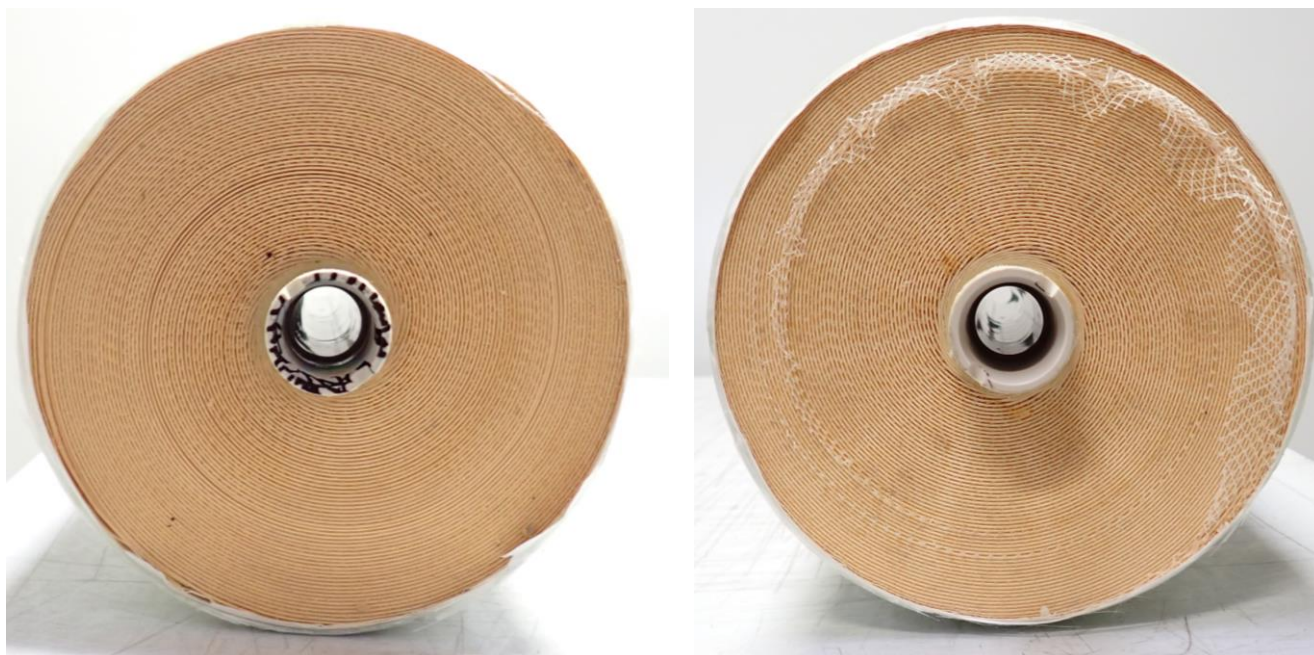
Results: Scroll gapping and feed spacer extrusion were observed on the feed and concentrate scroll ends, respectively. Several black-colored particles were observed on the feed scroll end.

Feed (left) and concentrate (right) scroll ends of SN 2190531452

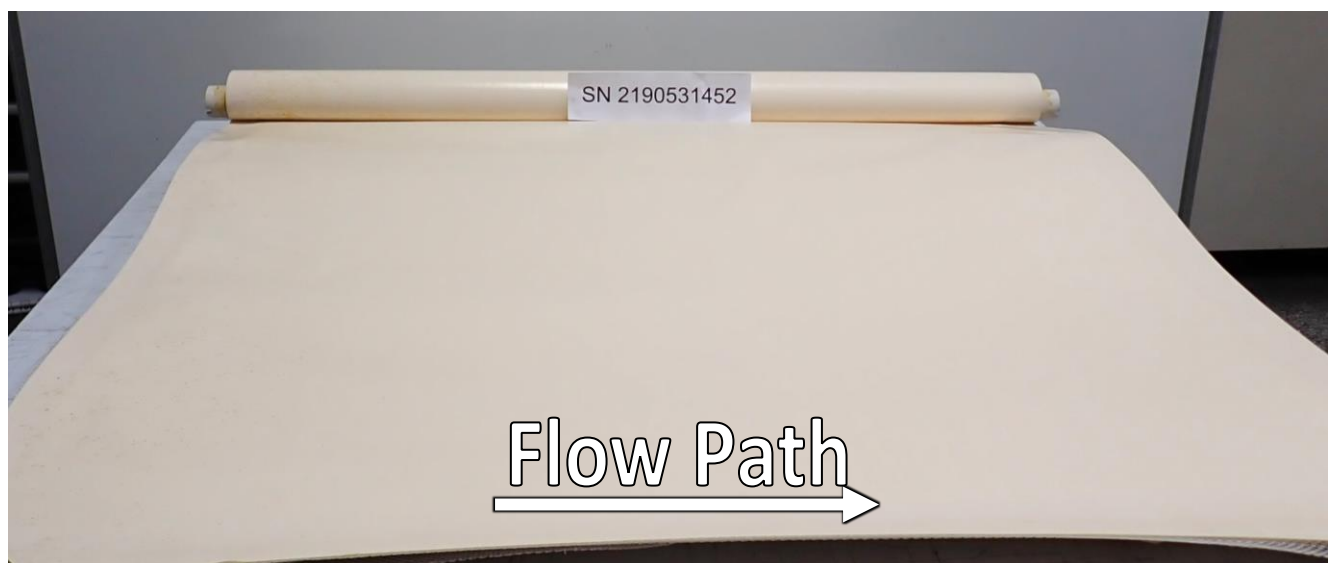
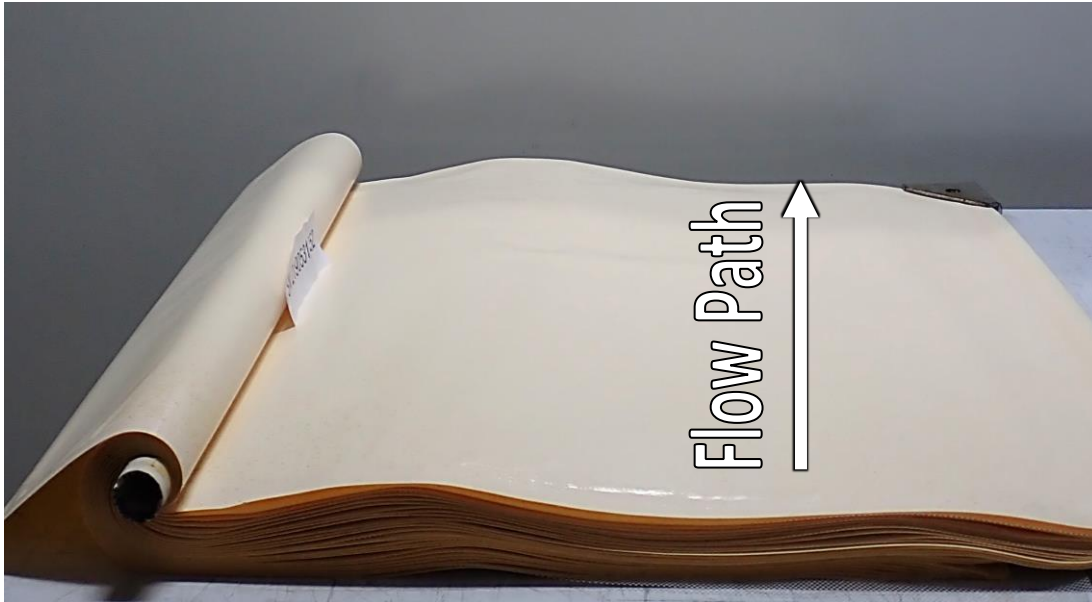
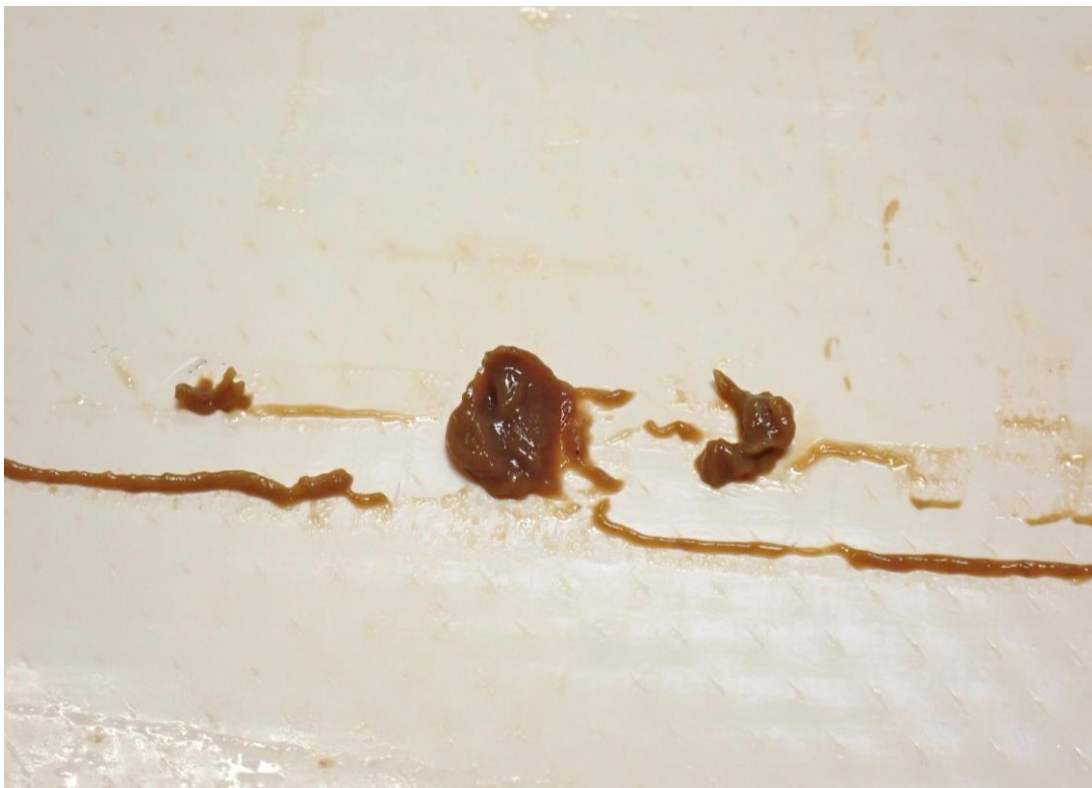
◆ **Results:** The exposed membrane surfaces were coated with gelatinous, tan-colored foulant material. The foulant was evenly distributed and removable via scraping. Upon closer inspection, there were also black-colored particles.

Exposed membrane surface of SN 2190531452

Exposed membrane surface from feed end of SN 2190531452

Foulant scraped on one membrane leaf of SN 2190531452

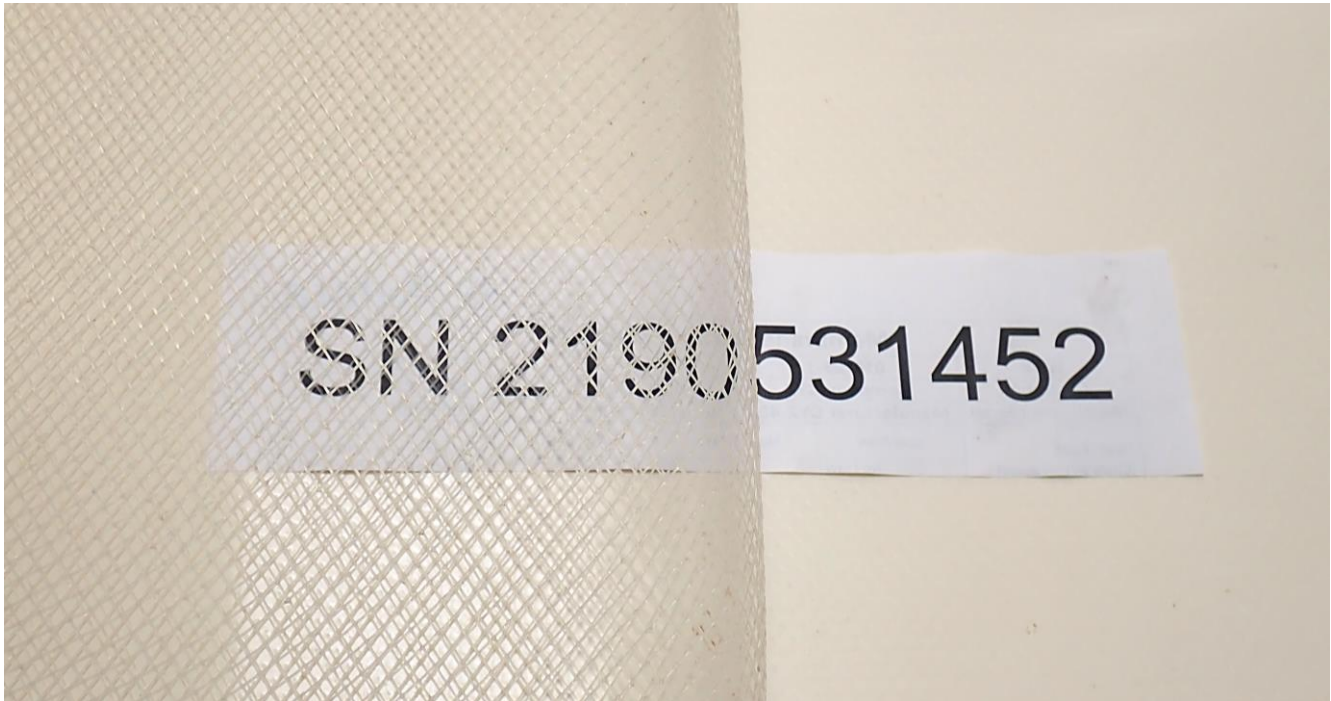
Results: The feed spacers of the element were absent of notable foulant and blockage.

Feed spacer of SN 2190531452

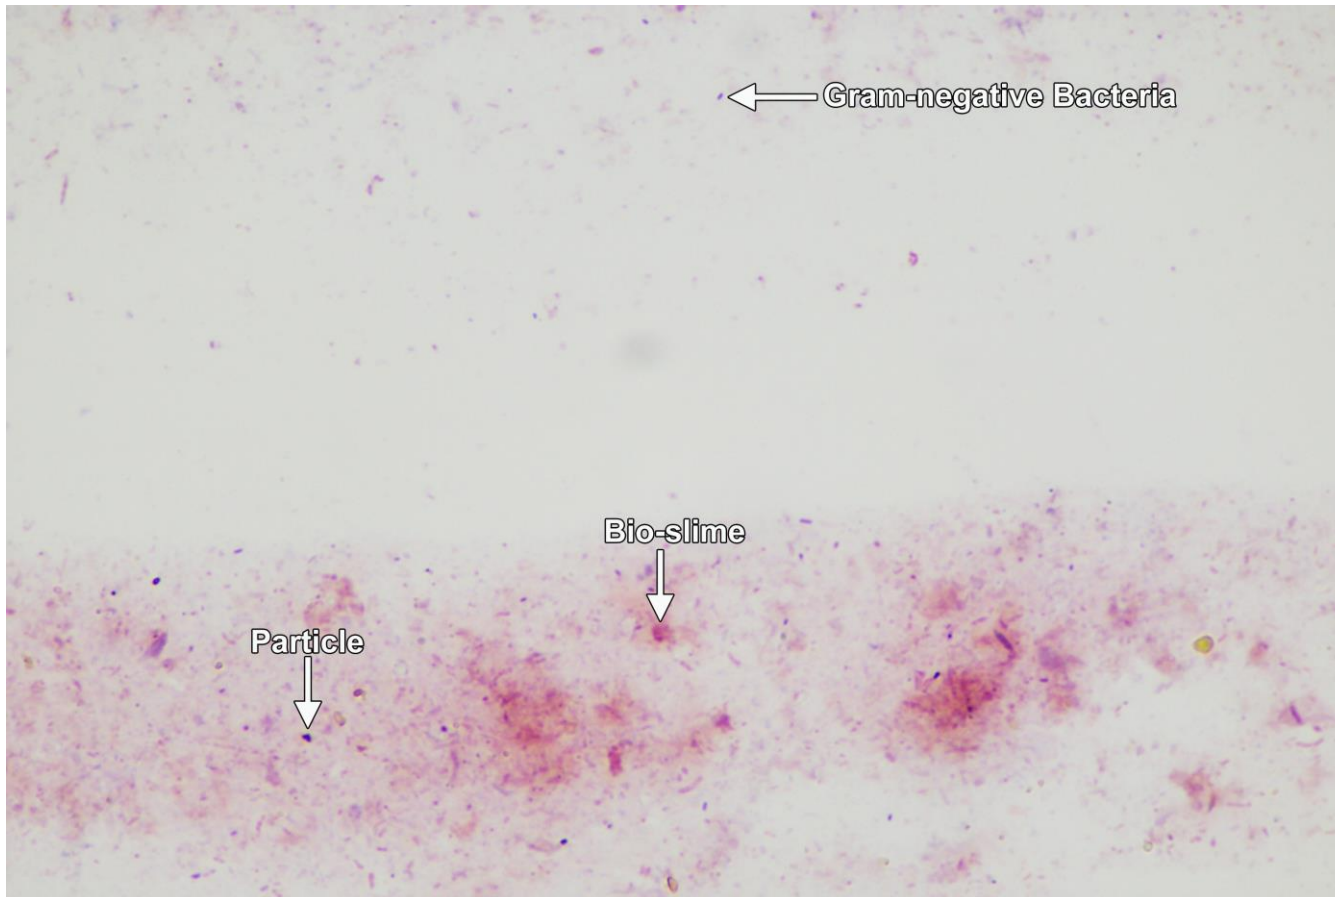
◆ **Results:** Microscope analysis identified bio-slime, particles and Gram-negative bacteria.

Light microscope image (1000x) of foulant scraped from SN 2190531452

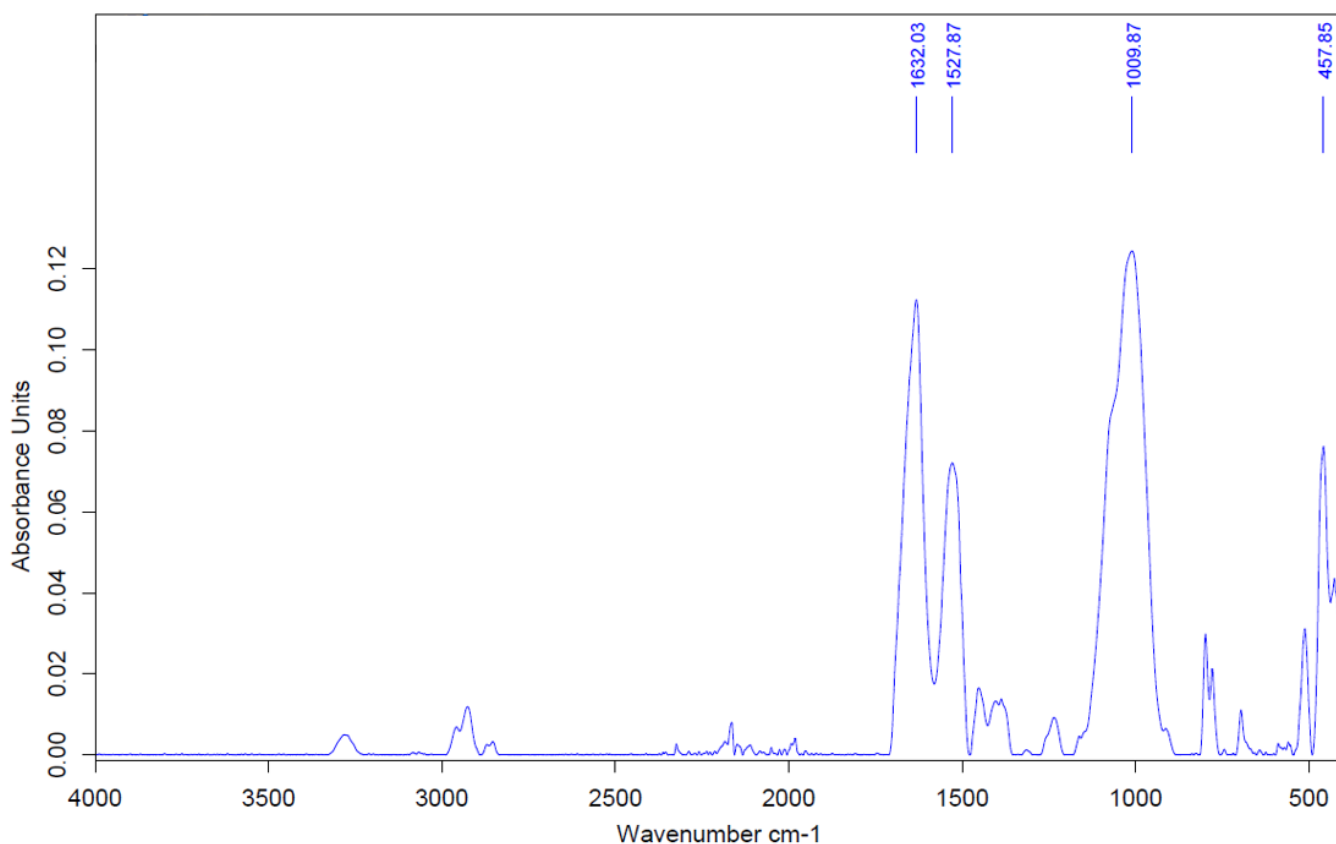
Compound	Wavelength (cm ⁻¹)
Clay/Silica	1000
Organics (bio-slime)	1100 – 900
Proteins (amino acids from microorganisms)	1650 – 1500

FT-IR spectral image of foulant removed from the membrane surface of SN 2190531452

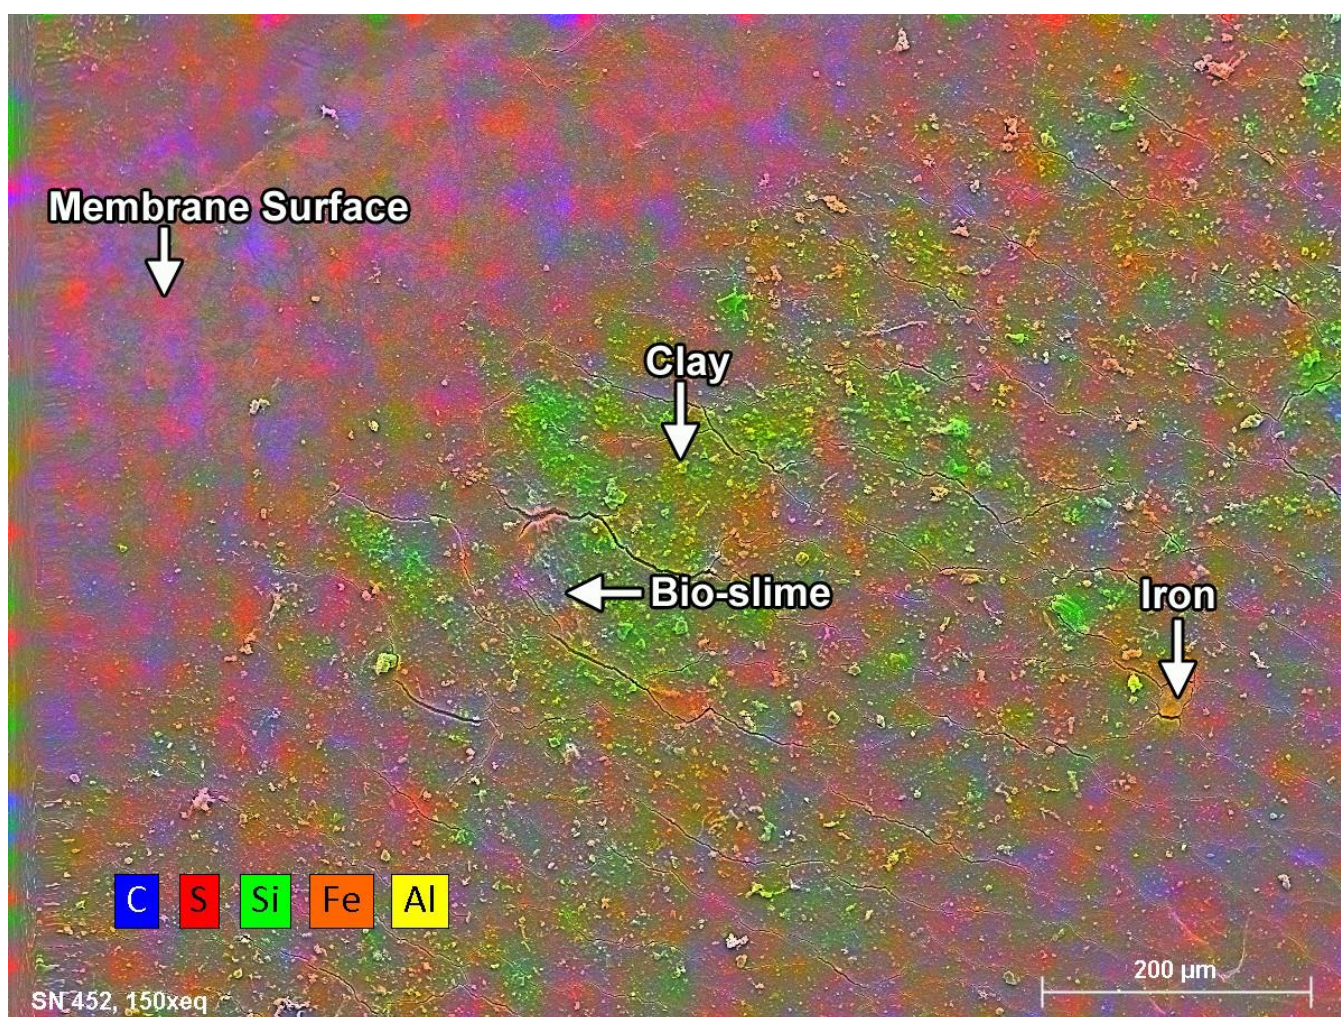
◆ **Results:** CEI revealed the foulant layer as a mixture of bio-slime (smooth, carbon-rich material) and clay (aluminum silicate – mixture of yellow and green). Colloidal silica (green), iron (orange) and microorganisms were also observed. The membrane surface (sulfur – red) was visible in areas where the foulant was less thick.

CEI image (150x) of the membrane surface with labels

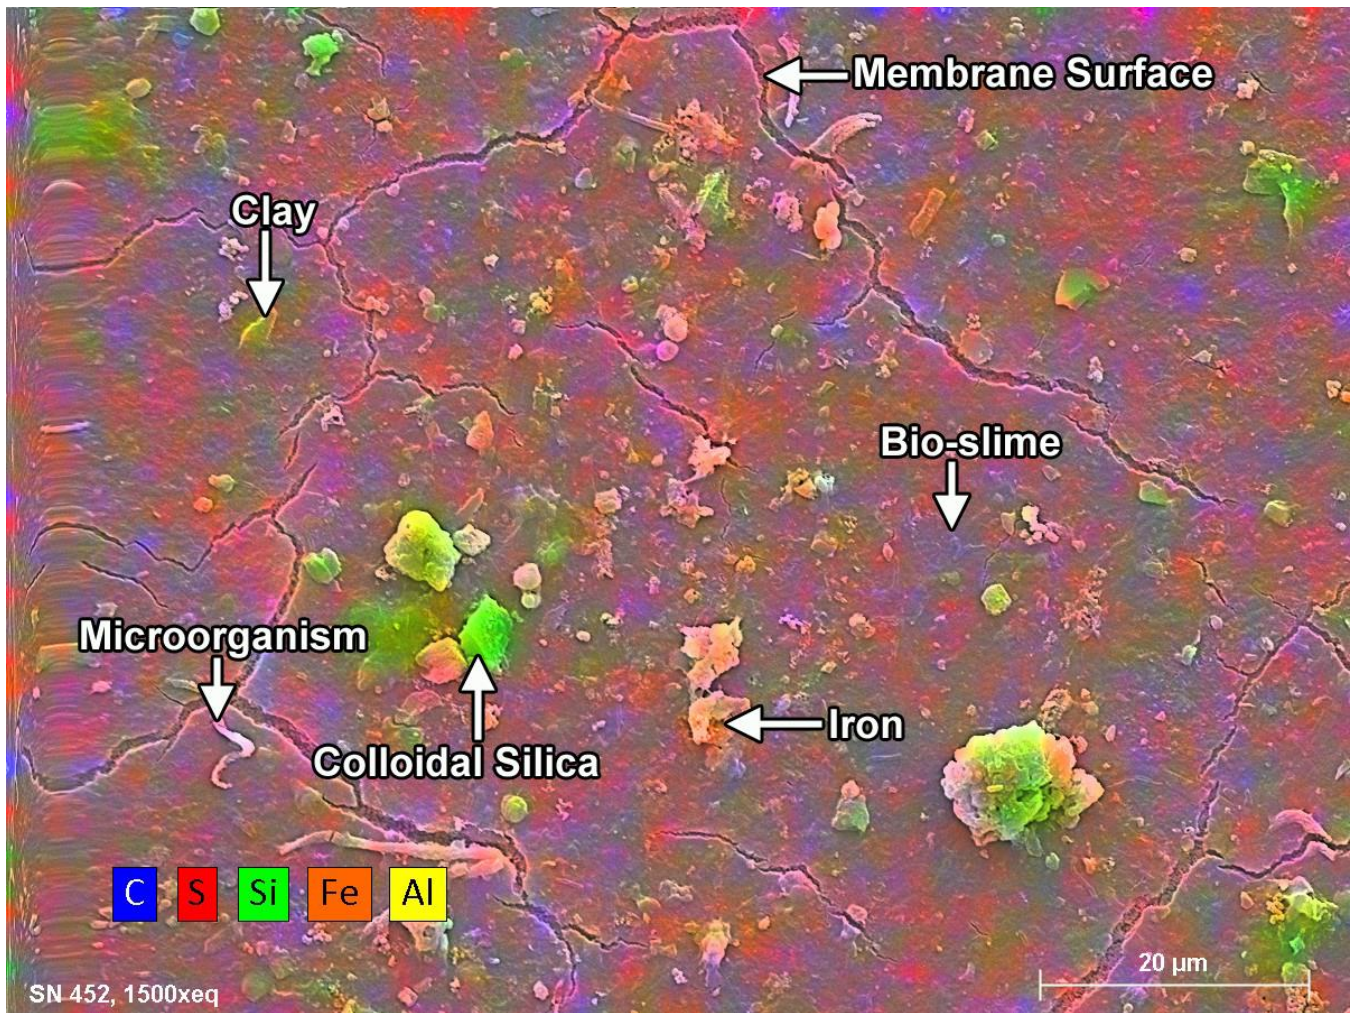
CEI image (1500x) of the membrane surface with labels

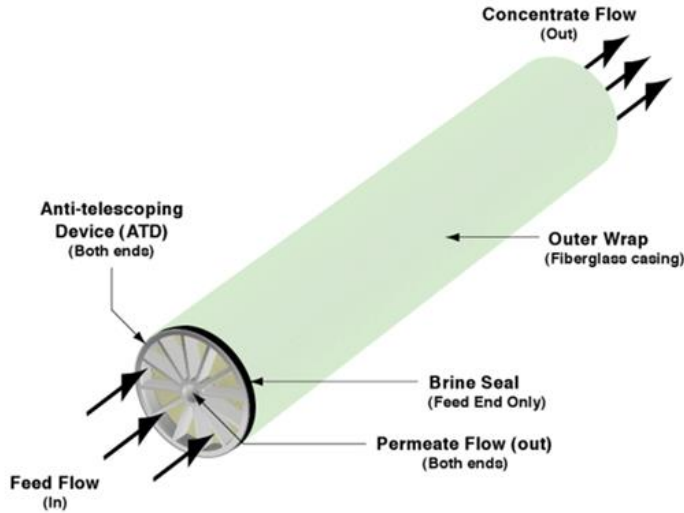
The leaves are "spiraled" around the product water tube

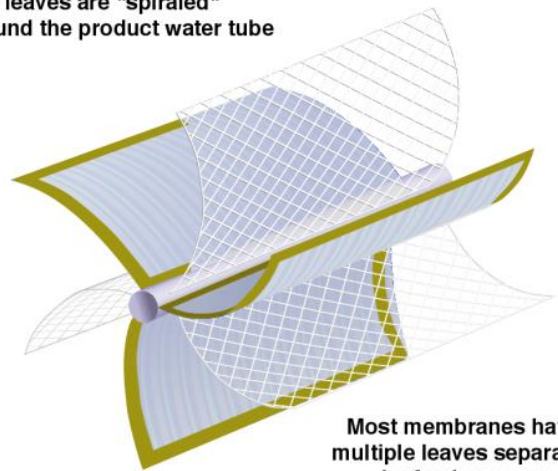
Most membranes have multiple leaves separated by feed spacers
