INFRASTRUCTURE COMMISSION

Western Springs Water Treatment Plant Condition Assessment

TECHNICAL MEMORANDUM

ALTERNATIVES TO AMIAD IRON REMOVAL SYSTEM

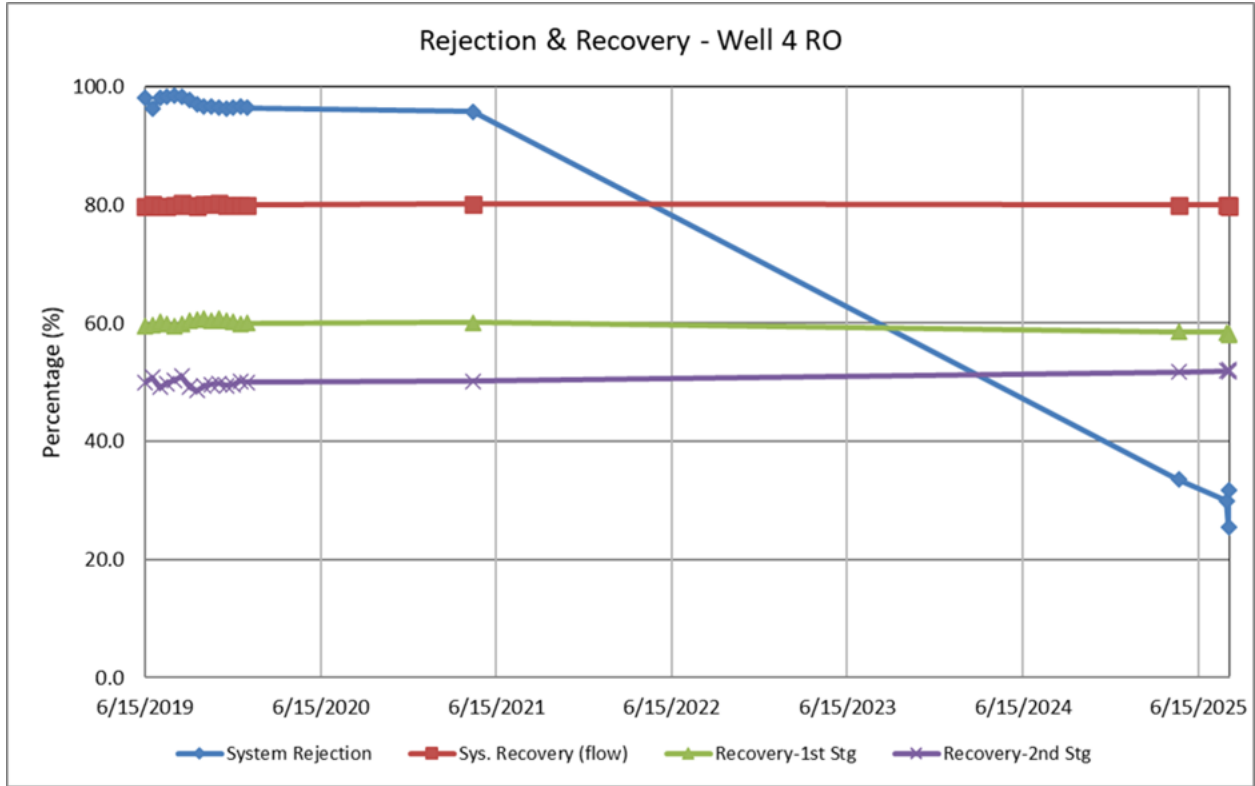
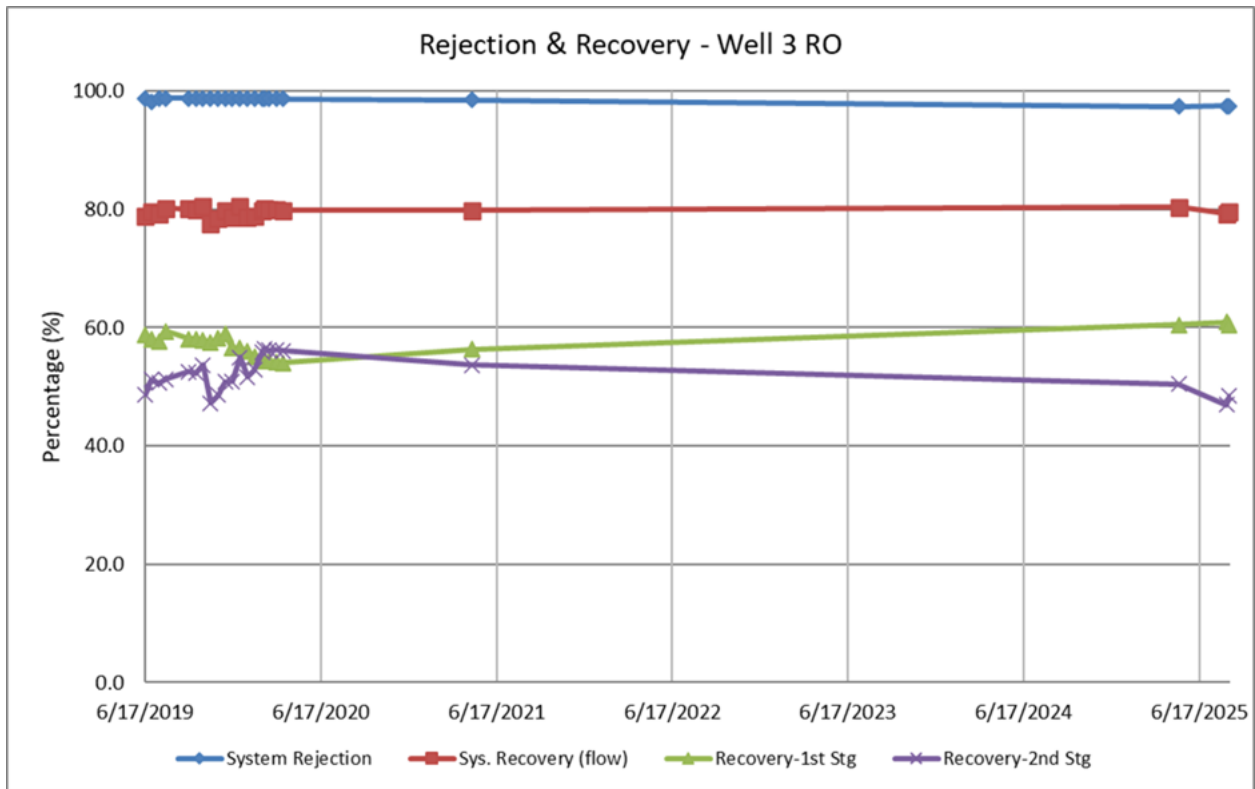
As you will see below, the data shows the rejection and recovery for Well 3 and Well 4 and the difference between the two units.
