INFRASTRUCTURE COMMISSION

Infrastructure Commission : May 14, 2026 at 6:00 PM
Village Hall 740 Hillgrove Avenue, Western Springs, IL 60558

- A. **Call to Order**
- B. **Approval of Minutes**
- C. **Public Comment**
- D. **New Business**
 - 1. 2025 Referendum Scoping Studies — Pre-Final Findings
- E. **Other Business**
- F. **Adjournment**

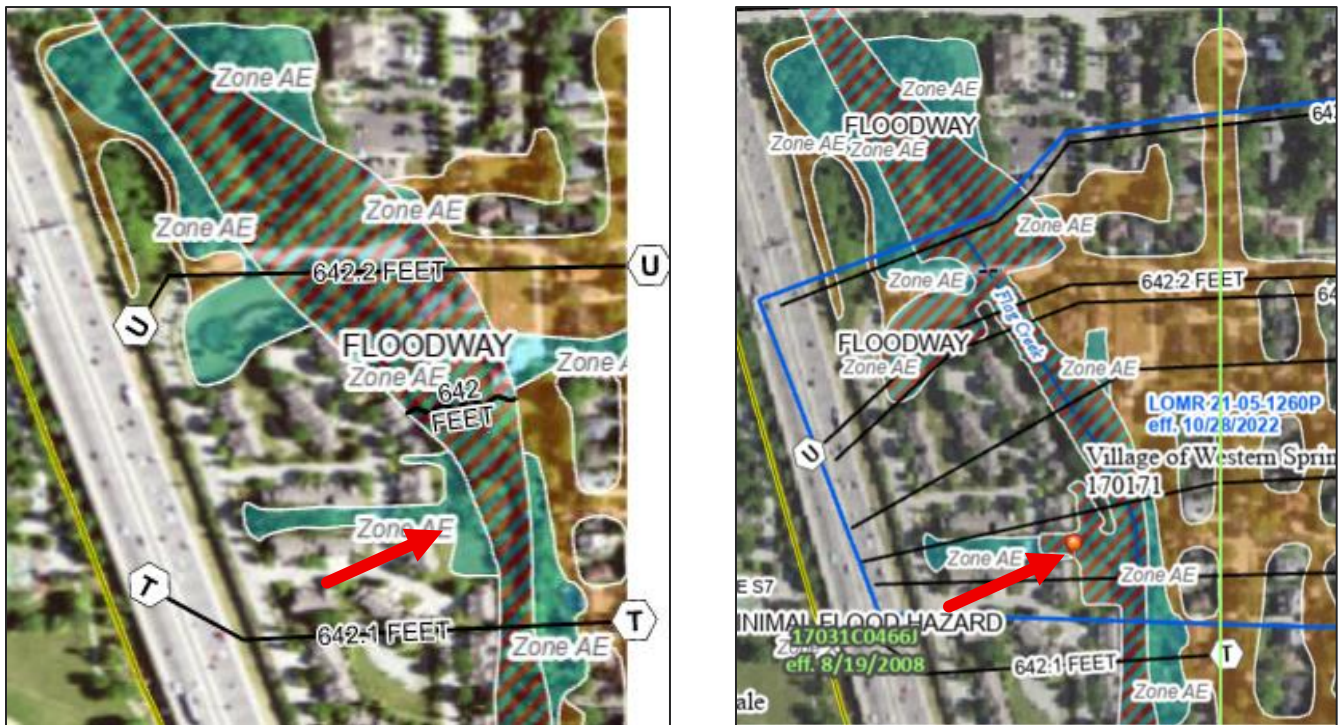
The Village requested for HR Green to investigate the reverse siphon along Flagg Creek, located between 49th Court North and 49th Court South along the 49th Street Ditch. Upon review of the FEMA floodplain maps, it appears that this area of Flagg Creek is located within FIRM panel 17031C0466J and became effective on August 19th, 2008. Additionally, a Letter of Map Revision (LOMR) was completed in this area which became effective on October 28th, 2022. **Figure 3** shows how the LOMR revised the floodplain and floodway near the reverse siphon location along 49th Street Ditch. The reverse siphon is now located within the Flagg Creek floodway and floodplain while before it was located in floodplain only. Improvements to the reverse siphon would require involvement of the IDNR-OWR and FEMA in the form of a conditional letter of map revision (CLOMR) and LOMR. The permit application can be costly, lengthy, and extensive. To the Village's knowledge, the Village does not own the reverse siphon and is not responsible for the maintenance and function of this structure. HR Green does not recommend improvements to this structure at this time. However, the Village should confirm ownership of the reverse siphon in case the structure needs to be repaired or maintained in the future.

Figure 3: FEMA FIRMette before and after LOMR 21-05-1260P became effective on 10/28/2022. Approximate location of reverse siphon is shown with red arrow.

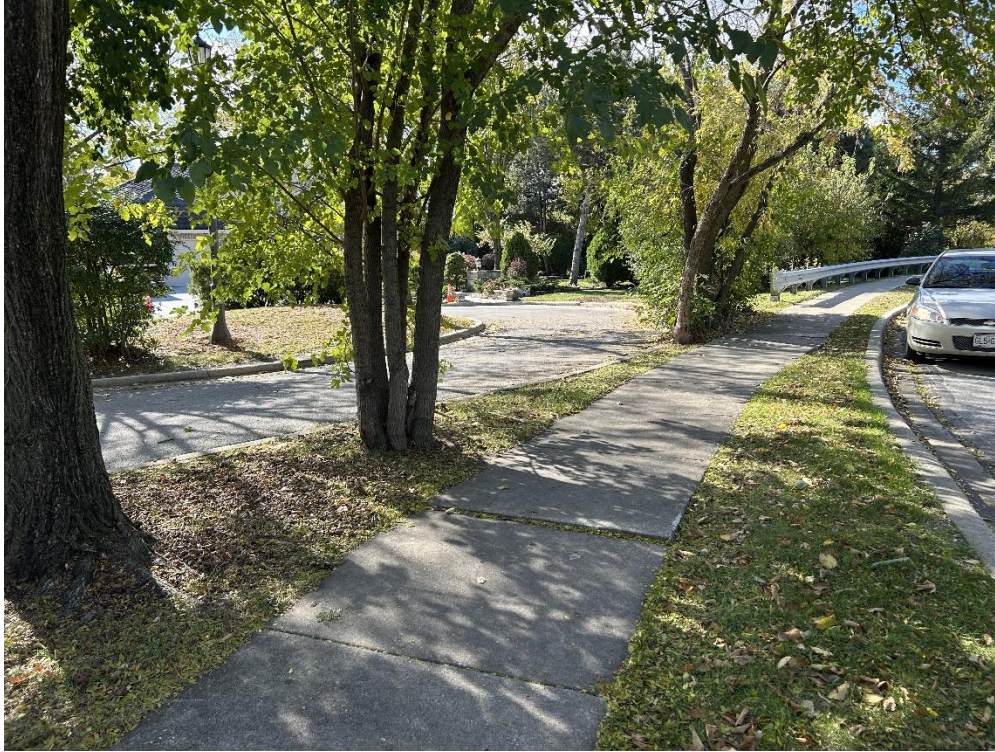
The Village requested HR Green to develop a conceptual intersection design to connect the existing W 48th Street cul-de-sac to Commonwealth Avenue. Currently, the two roadways do not intersect, but are separated by a 10-foot wide parkway with sidewalk (see **Figure 5**). The existing cul-de-sac has substandard geometry with a center island which makes it difficult to perform snowplowing activities in the winter months. Please see **Appendix 3** for the conceptual exhibit.

Figure 5: Parkway between W 48th Street cul-de-sac (left) and Commonwealth Avenue (right), looking southwest

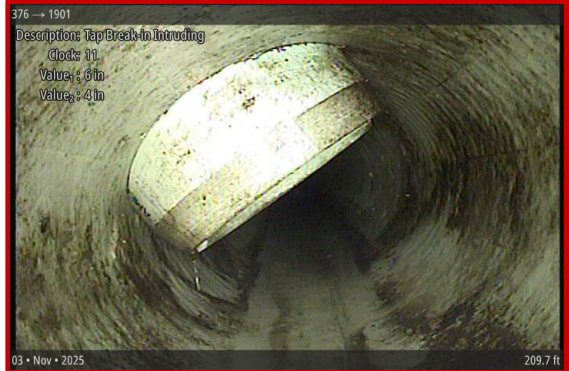
[Grade 5] Tap Break-in Intruding at 209.7 ft, 11 o'clock

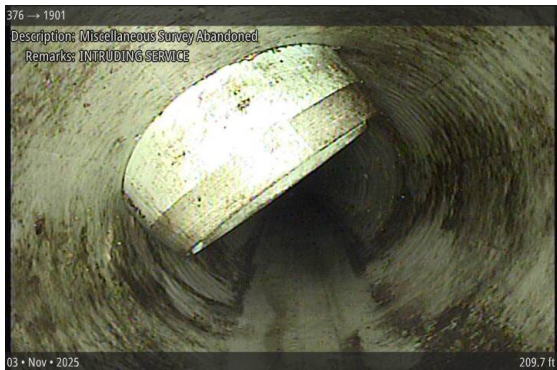
Miscellaneous Survey Abandoned at 209.7 ft | INTRUDING SERVICE

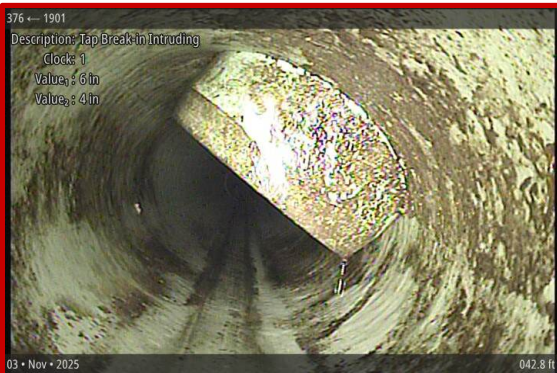
[Grade 5] Tap Break-in Intruding at 042.8 ft, 1 o'clock

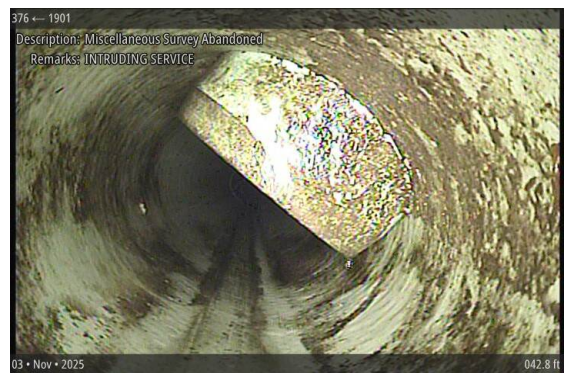
Miscellaneous Survey Abandoned at 042.8 ft | INTRUDING SERVICE

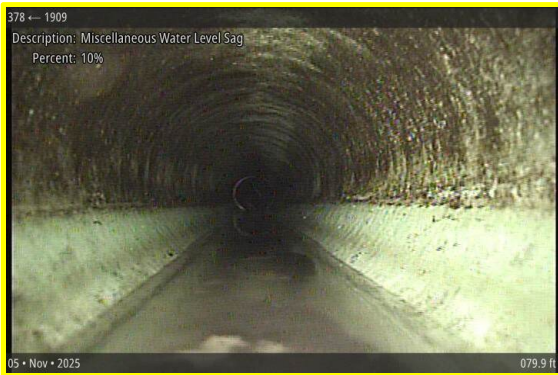
[Grade 2] Miscellaneous Water Level Sag at 079.3 ft

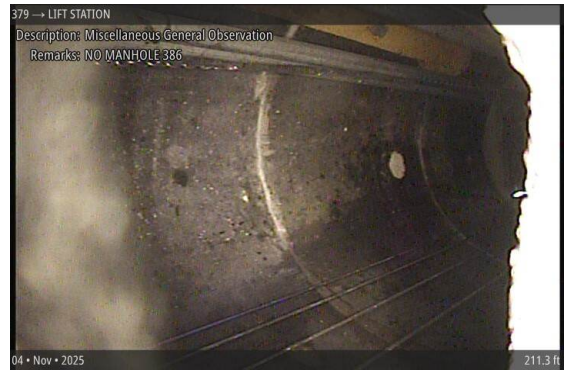
Miscellaneous General Observation at 211.3 ft | NO MANHOLE 386

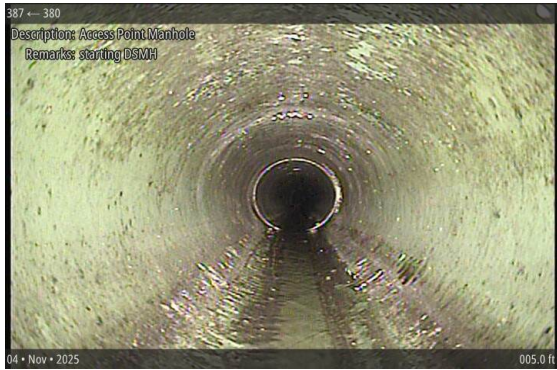
Access Point Manhole at 000.0 ft | starting DSMH

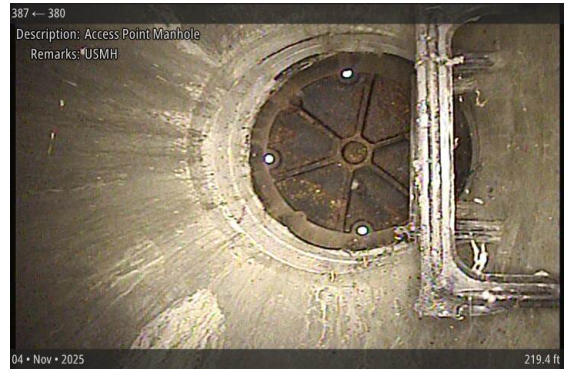
Access Point Manhole at 219.4 ft | USMH

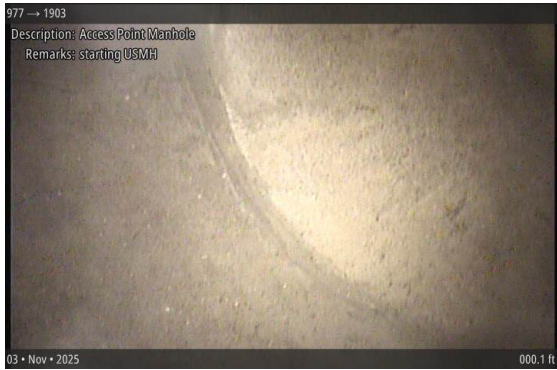
Access Point Manhole at 000.0 ft | starting USMH

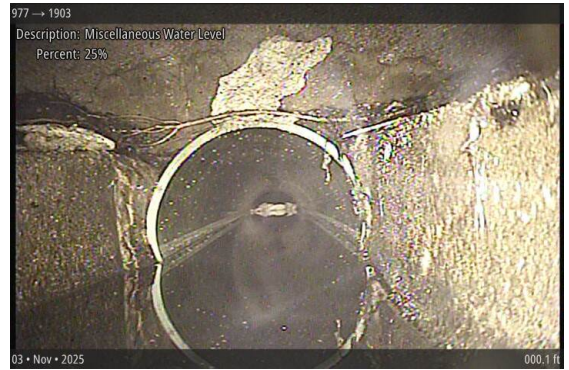
Miscellaneous Water Level at 000.0 ft

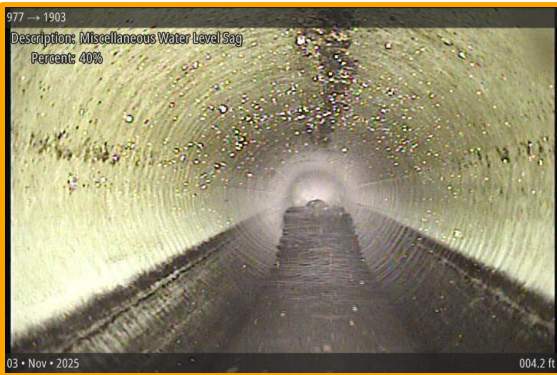
[Grade 3] Miscellaneous Water Level Sag (start) at 000.2 ft

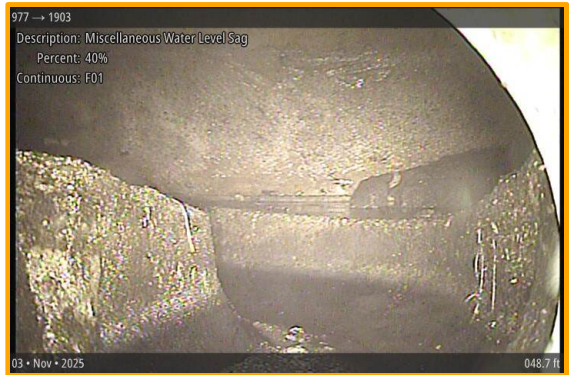
[Grade 3] Miscellaneous Water Level Sag (finish) at 048.7 ft

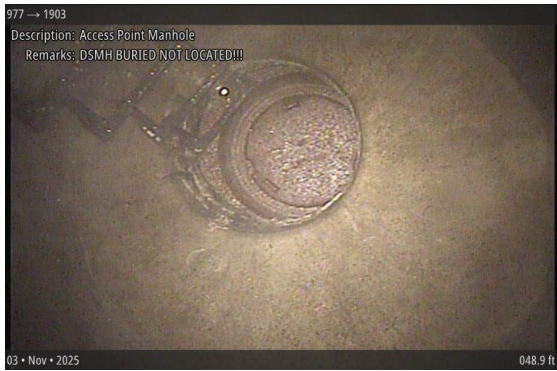
Access Point Manhole at 048.9 ft | DSMH BURIED NOT LOCATED!!!

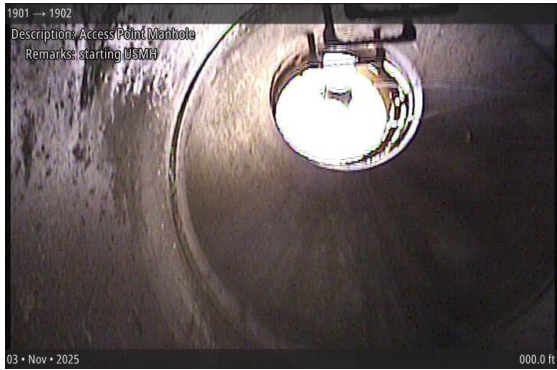
Access Point Manhole at 000.0 ft | starting USMH

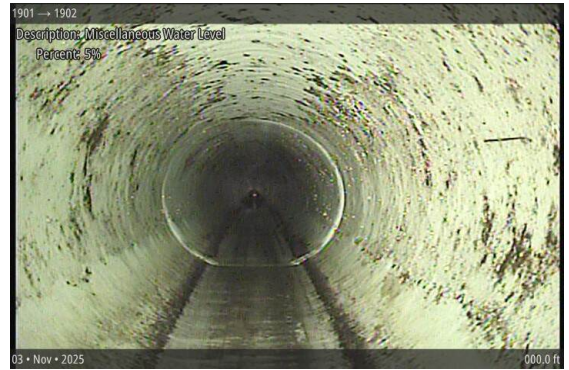
Miscellaneous Water Level at 000.0 ft

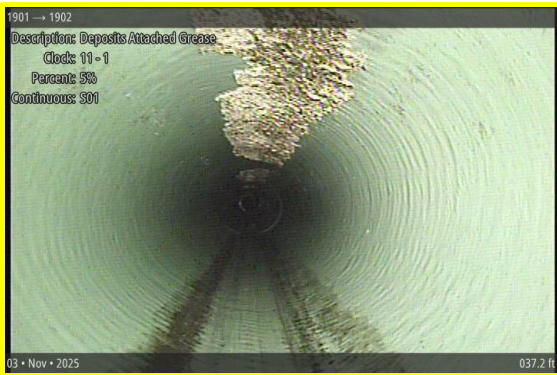
[Grade 2] Deposits Attached Grease (start) at 037.2 ft, 11 - 1 o'clock

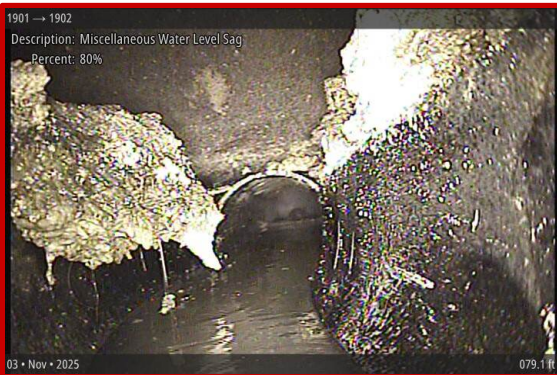
[Grade 5] Miscellaneous Water Level Sag at 079.1 ft

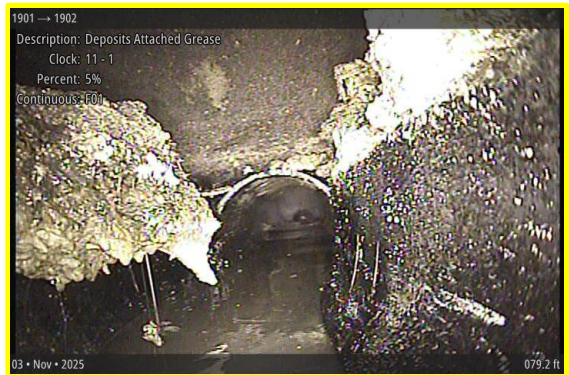
[Grade 2] Deposits Attached Grease (finish) at 079.1 ft, 11 - 1 o'clock

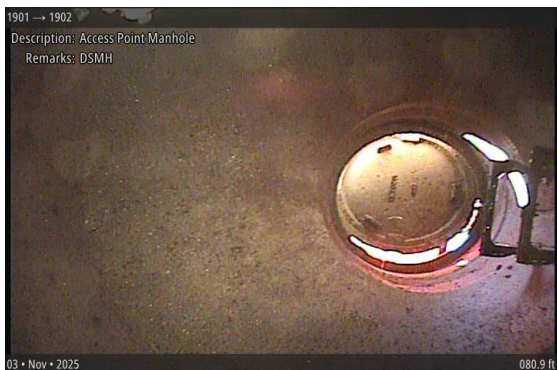
Access Point Manhole at 080.9 ft | DSMH

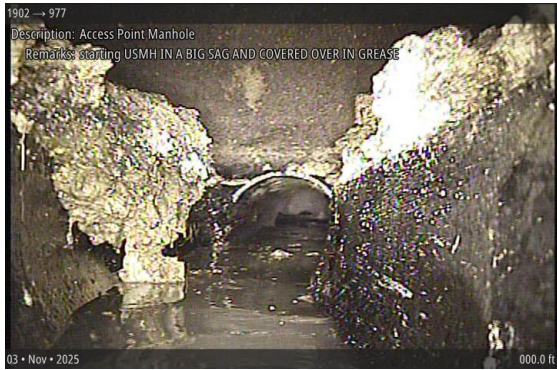
Access Point Manhole at 000.0 ft | starting USMH IN A BIG SAG AND COVERED OVER IN GREASE

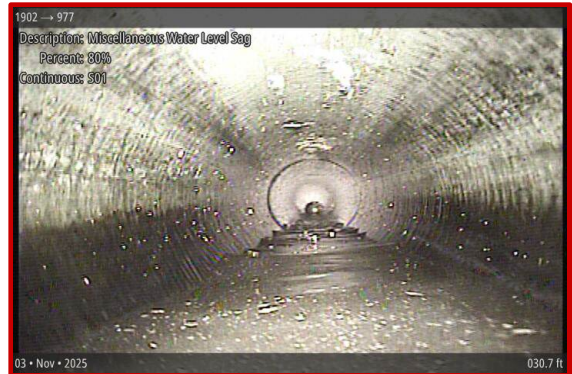
[Grade 5] Miscellaneous Water Level Sag (start) at 000.1 ft

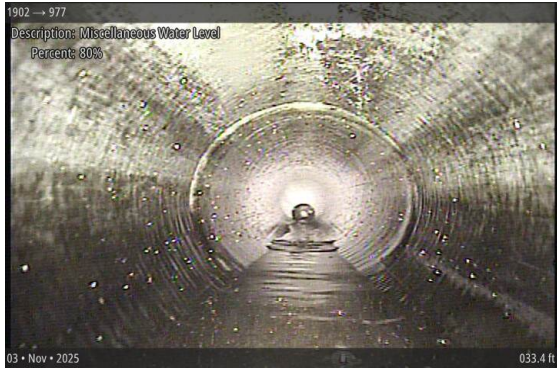
Miscellaneous Water Level at 000.0 ft

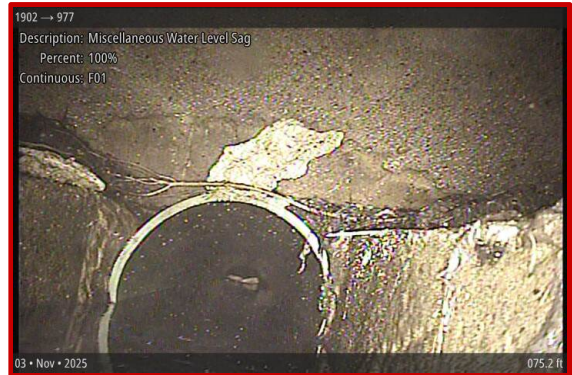
[Grade 5] Miscellaneous Water Level Sag (finish) at 075.1 ft

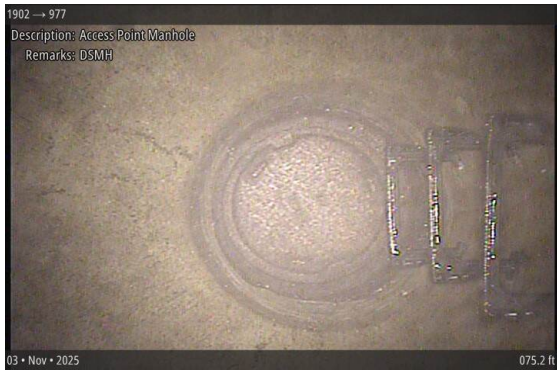
Access Point Manhole at 075.2 ft | DSMH

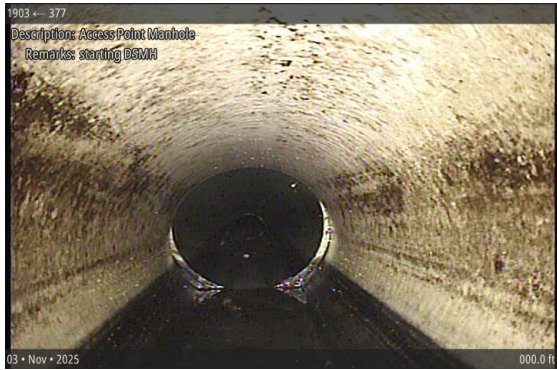
Access Point Manhole at 000.0 ft | starting DSMH

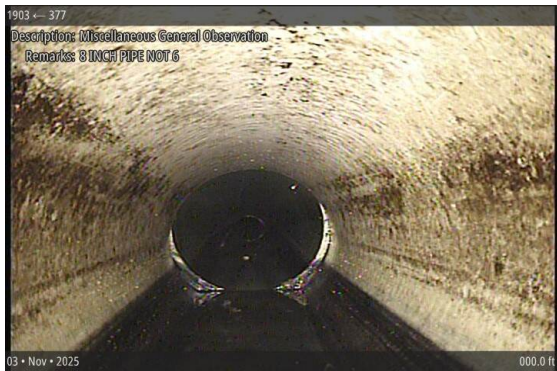
Miscellaneous General Observation at 000.0 ft | 8 INCH PIPE NOT 6

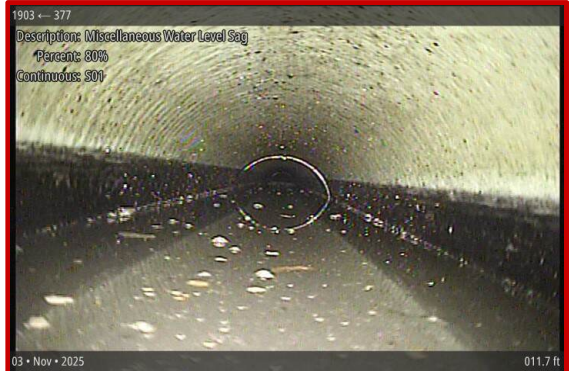
[Grade 5] Miscellaneous Water Level Sag (start) at 011.7 ft

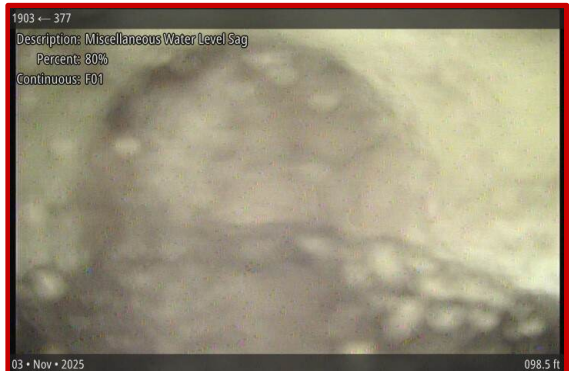
[Grade 5] Miscellaneous Water Level Sag (finish) at 098.5 ft

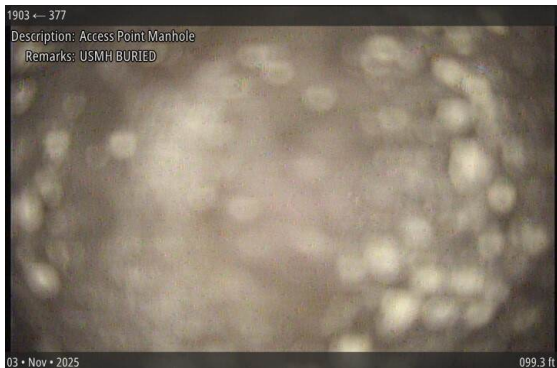
Access Point Manhole at 099.3 ft | USMH BURIED

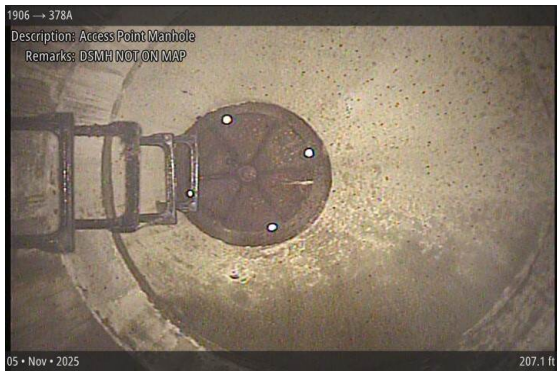
Access Point Manhole at 207.1 ft | DSMH NOT ON MAP

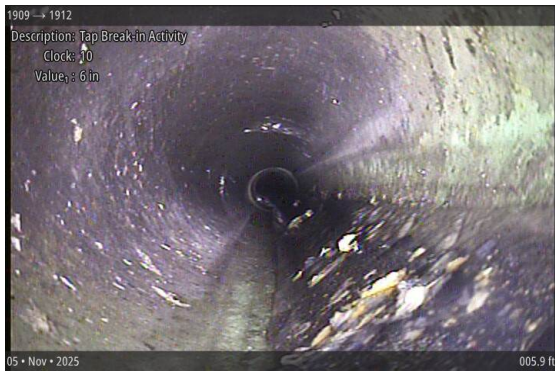
Tap Break-in Activity at 005.9 ft, 10 o'clock

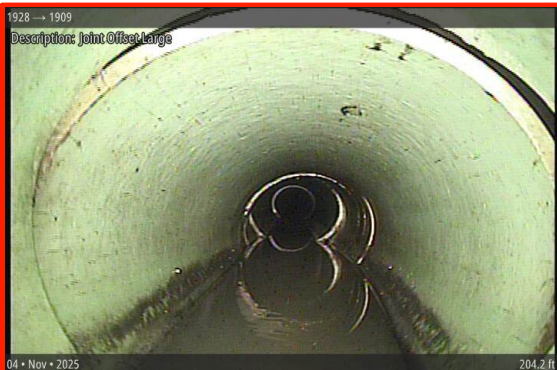
[Grade 4] Joint Offset Large at 204.2 ft

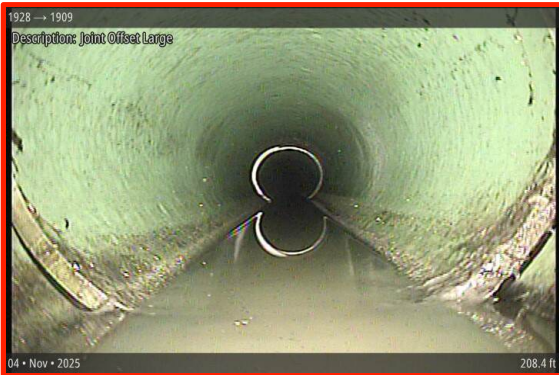
[Grade 4] Joint Offset Large at 208.4 ft

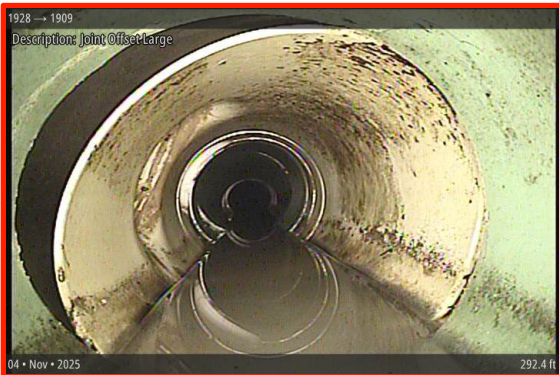
[Grade 4] Joint Offset Large at 292.4 ft

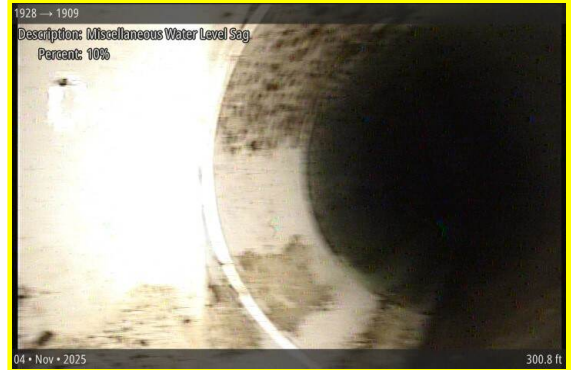
[Grade 2] Miscellaneous Water Level Sag at 300.8 ft

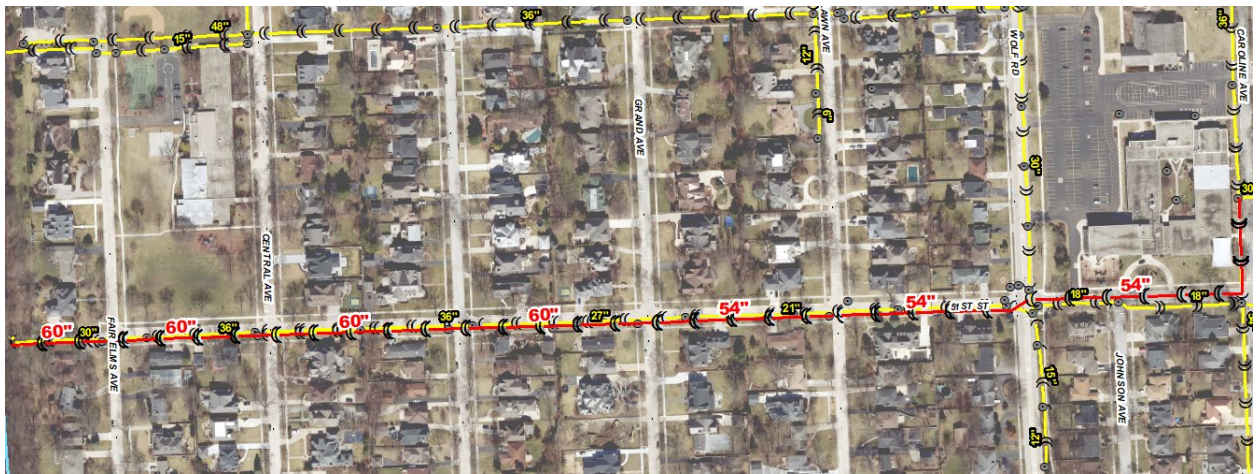
Figure 4. Upsized and New Storm Sewer on 51st Street from Caroline Ave to Flagg Creek

This alternative would significantly reduce ponding on Wolf Road so that it would remain passable to vehicular traffic in a 100-year storm event. It would also provide benefits to the area between 51st and 53rd Streets west of Wolf Road by reducing the amount of overland flow that reaches this area. The depths of ponding would be reduced by approximately 0.2' in those areas.

Alternative 1B was developed to examine the improvements that would be required to provide further protection so that 100-year ponding depth is limited to approximately one foot at the curblines. The entirety of the Village's 51st Street storm sewer would be removed and upsized from Caroline Avenue to the Flagg Creek as shown on **Figure 4** and **Exhibits 13 & 14**. The existing CCDOTH storm sewer would remain undisturbed.
