INFRASTRUCTURE COMMISSION

Infrastructure Commission : May 14, 2026 at 6:00 PM
Village Hall 740 Hillgrove Avenue, Western Springs, IL 60558

- A. **Call to Order**
- B. **Approval of Minutes**
- C. **Public Comment**
- D. **New Business**
 - 1. 2025 Referendum Scoping Studies — Pre-Final Findings
- E. **Other Business**
- F. **Adjournment**

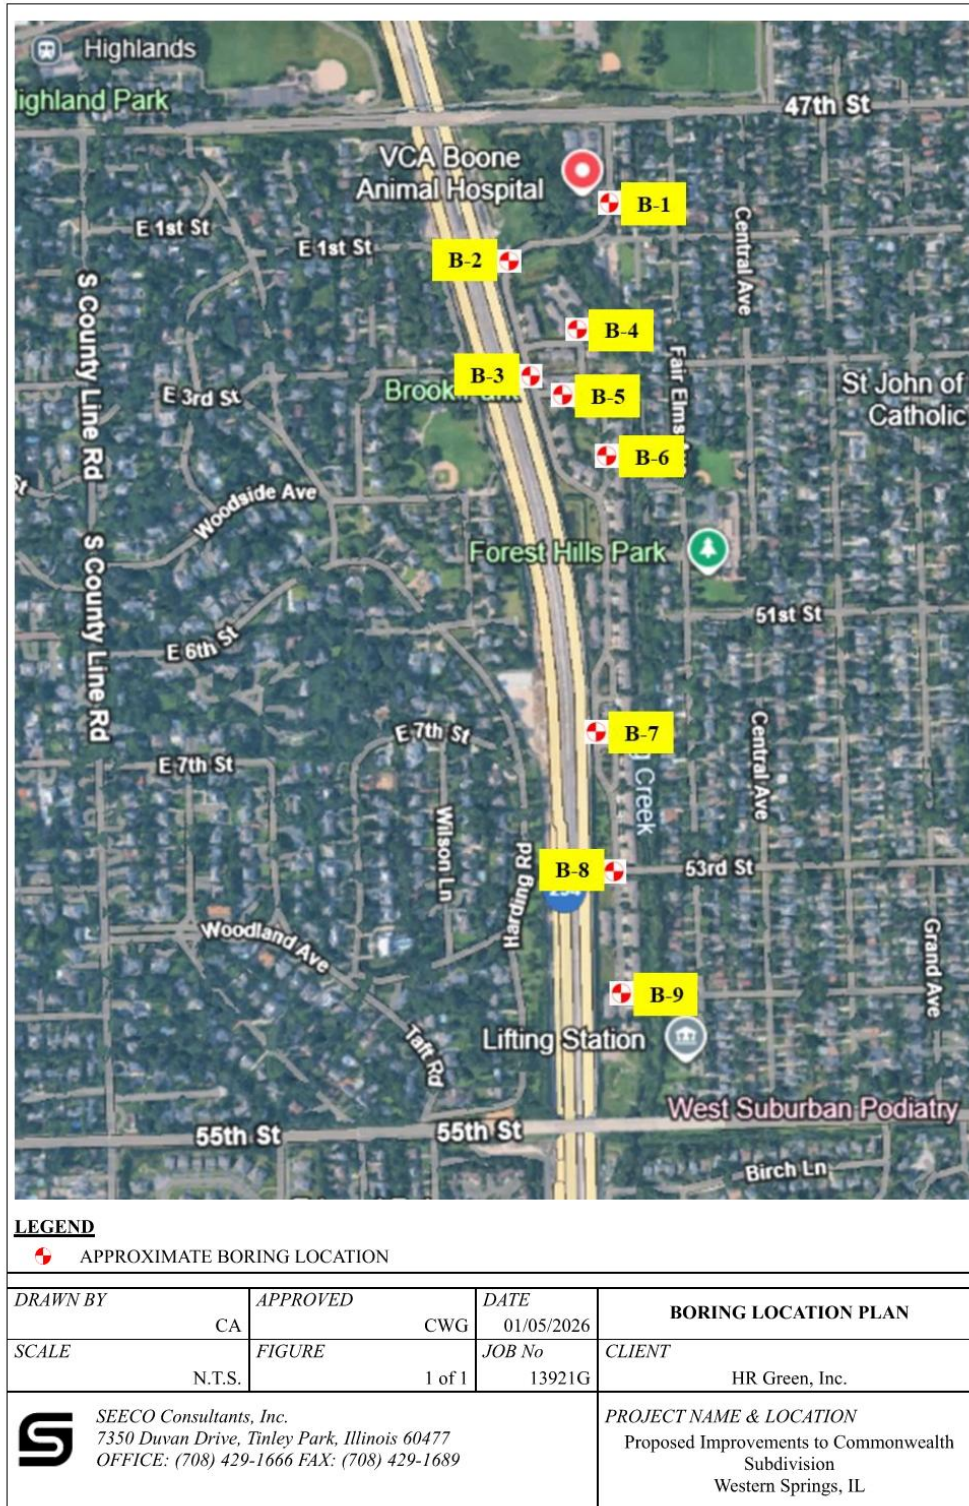
Figure 1: Boring Location Map (from Geotech Report)

HR Green's subconsultant, Seeco Consultants, Inc., prepared a geotechnical assessment within the project area. Nine soil borings were drilled and sampled to a depth of 10-foot below existing ground level. **Figure 1** provides the Soil Boring Location Map. According to the report, the soils along Creek Drive (Boring No. 6) and southern limits of Commonwealth Avenue (Boring No. 9) were found to be unsuitable and may require undercut excavation up to 2 feet below typical watermain invert depth (see **Table 1**). Seeco Consultants recommends filling the undercut with compact IDOT CA-6 crushed stone. The remaining seven soil borings appeared to have suitable soils. The average thickness of the existing roadway pavement was found to be approximately 4 inches with an average crushed stone base course thickness of approximately 14 inches (see **Table 2**). According to the geotechnical report, the existing hard/very stiff dark gray clay fill and very stiff dark gray and gray clay fill subgrade below the existing pavement are suitable as subgrade. The detailed geotechnical report, boring logs, and design recommendations are provided in **Appendix 5**.

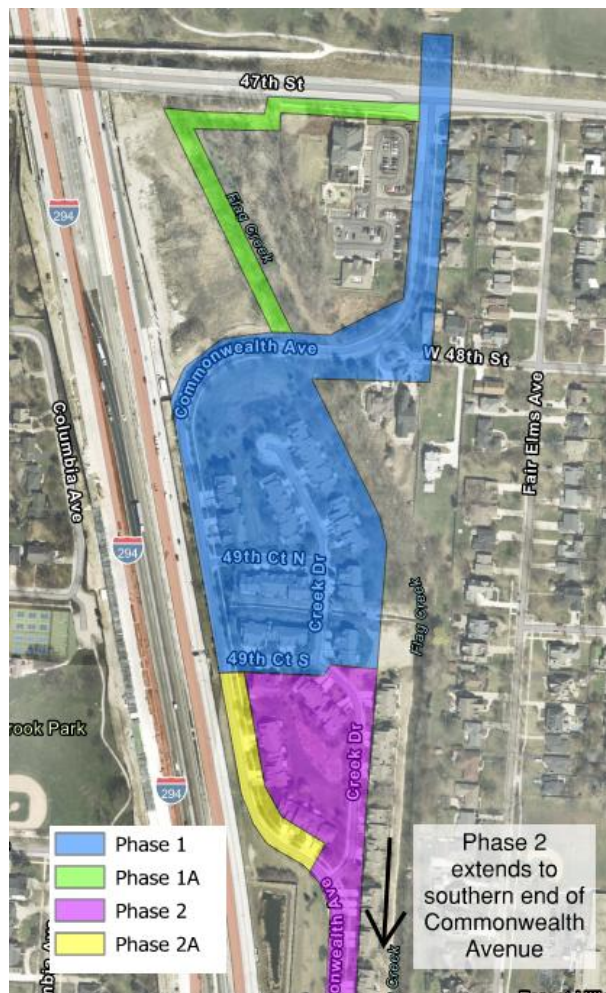
The proposed watermain alignments are provided in **Appendix 1**. Improvements were subdivided into Phase 1 and Phase 2 with 49th Court South serving as the dividing line between the two phases. Within Phase 1, there is also a Phase 1 Alternate for the additional cost required to re-route the watermain for the future emergency interconnect at 47th Street. Within Phase 2, there is Phase 2A which includes the option to relocate an existing 6-inch watermain off private property and into the right of way. The purpose of subdividing the project into multiple phases is to distribute the project costs among multiple fiscal years and to split the work into smaller, more manageable project sizes. **Figure 4** provides an overall map showing the location of the phase boundaries.

Figure 4: Overall map showing the phasing proposed for the Commonwealth Subdivision improvements

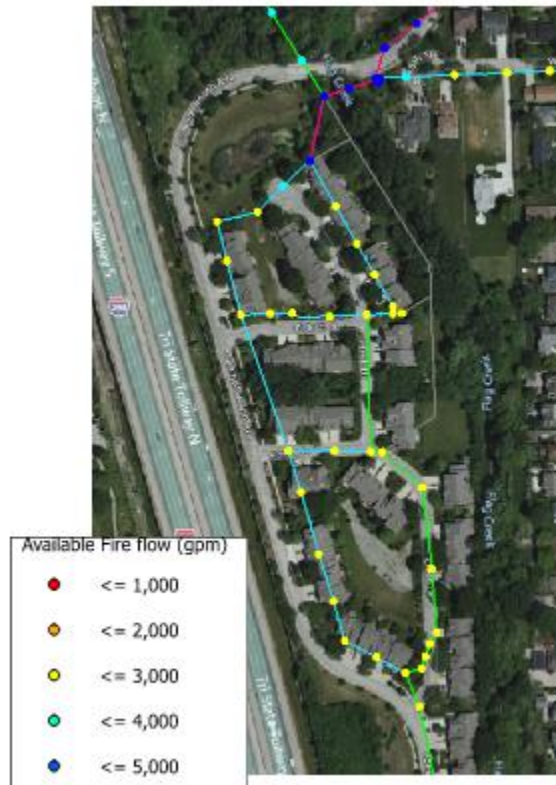
HR Green modeled the proposed watermain alignment to confirm if the new configuration will impact the water system. The minimum system pressures during the average day demand remained between 50 psi and 60 psi. The new configuration will improve fire protection along the 6-inch watermain with new fire flows ranging between 2,000 to 3,000 gpm, as shown in **Figure 9**.

Figure 9: Available Fire Flow for proposed watermain alignment

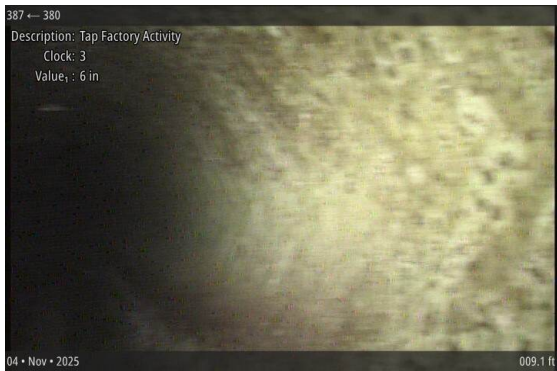
Tap Factory Activity at 009.1 ft, 3 o'clock

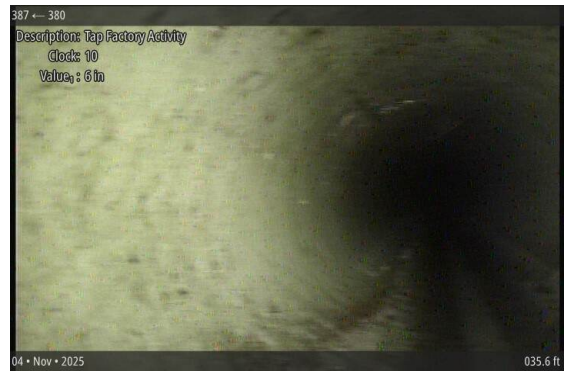
Tap Factory Activity at 035.6 ft, 10 o'clock

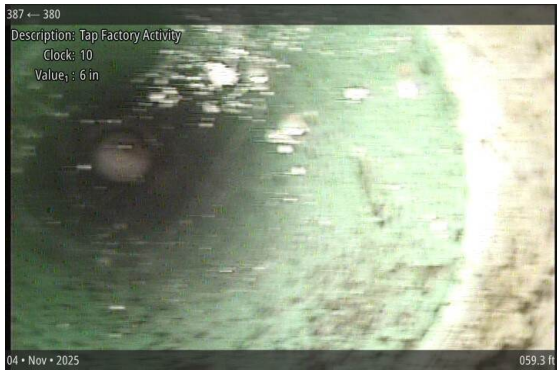
Tap Factory Activity at 059.3 ft, 10 o'clock

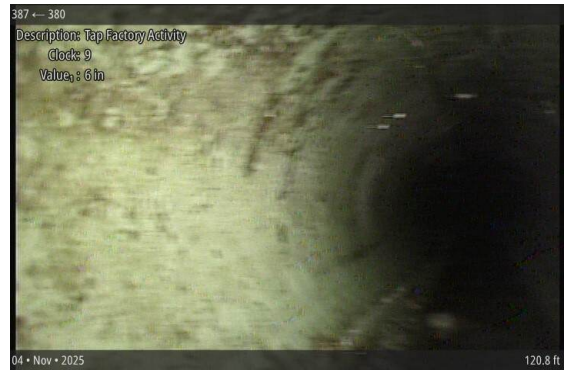
Tap Factory Activity at 120.8 ft, 9 o'clock

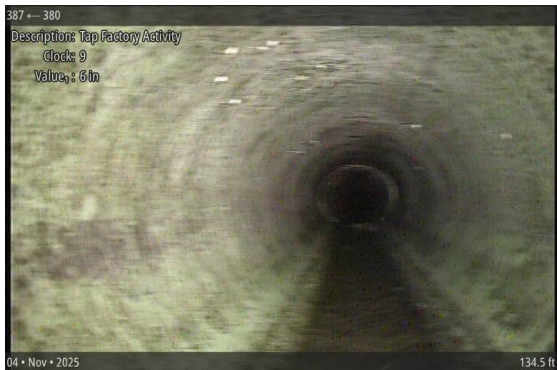
Tap Factory Activity at 134.5 ft, 9 o'clock

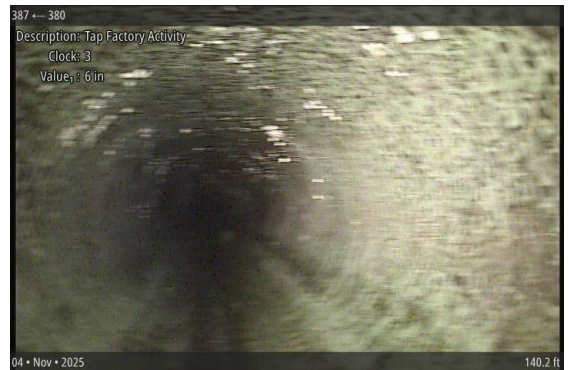
Tap Factory Activity at 140.2 ft, 3 o'clock

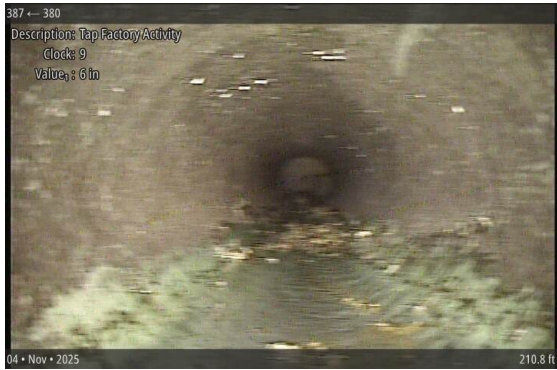
Tap Factory Activity at 210.8 ft, 9 o'clock

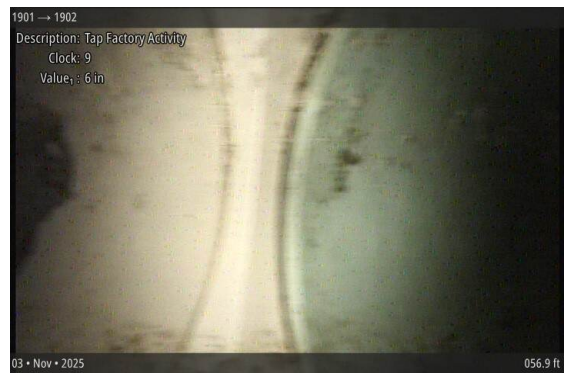
Tap Factory Activity at 056.9 ft, 9 o'clock

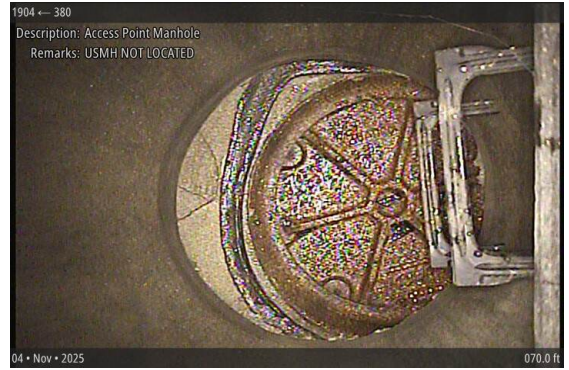
Access Point Manhole at 070.0 ft | USMH NOT LOCATED

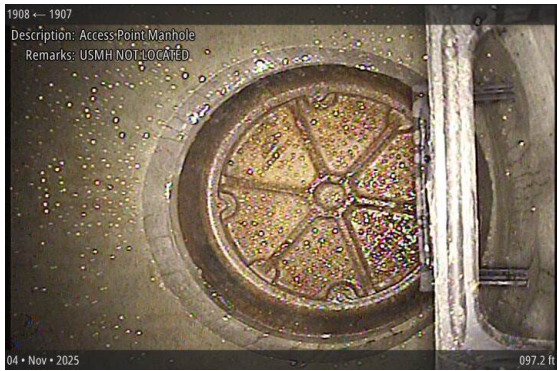
Access Point Manhole at 097.2 ft | USMH NOT LOCATED

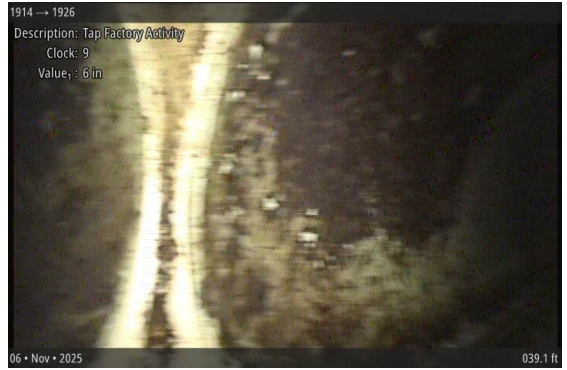
Tap Factory Activity at 039.1 ft, 9 o'clock

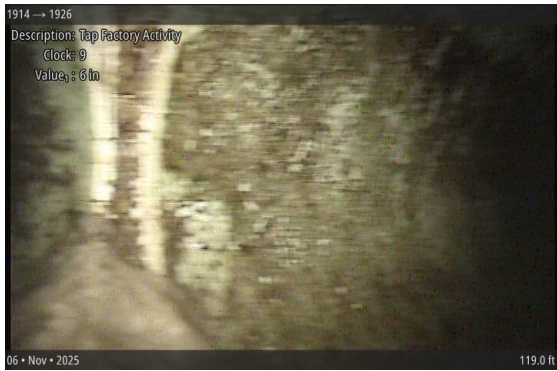
Tap Factory Activity at 119.0 ft, 9 o'clock
